Appendix G – Wildlife Site Visit Report

Wildlife Hazard Site Visit

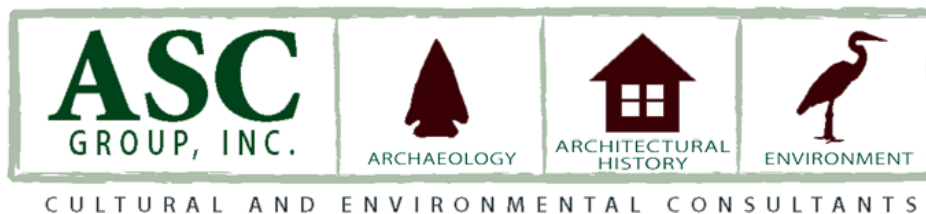
REPORT TRACKING SHEET			
PI:		PM: Andy	
Date: 12/1/2016	Project No: 2336	Client: Woolpert	
Project: SBA – Wildlife Hazard SV	PID/DES#: N/A	Copies to client:	
Author(s): Stu Jennings	Clerical: Rhodes	Report Due:	
Comments/Special Instructions			
REVIEWERS:	Date of Draft	Date of Review	Date Revisions Checked
Shaune			
David K.			
Kevin S.			
Rae		12/2/2016; 12/5/2016	12/5/2016
Andy	11/28/2016	11/28/2016	
Annette			
Doug			
Date Comments Received:			
REVIEWERS:	Date of Draft	Date of Review	Date Revisions Checked
Shaune			
Rae			
David K.			
Kevin S.			
Andy			
Annette			
Final copied by:			
Final paged through by:			
Sent to client via email:		(via) UPS:	
Copies of transmittal, title page and tracking sheet to Debbie:

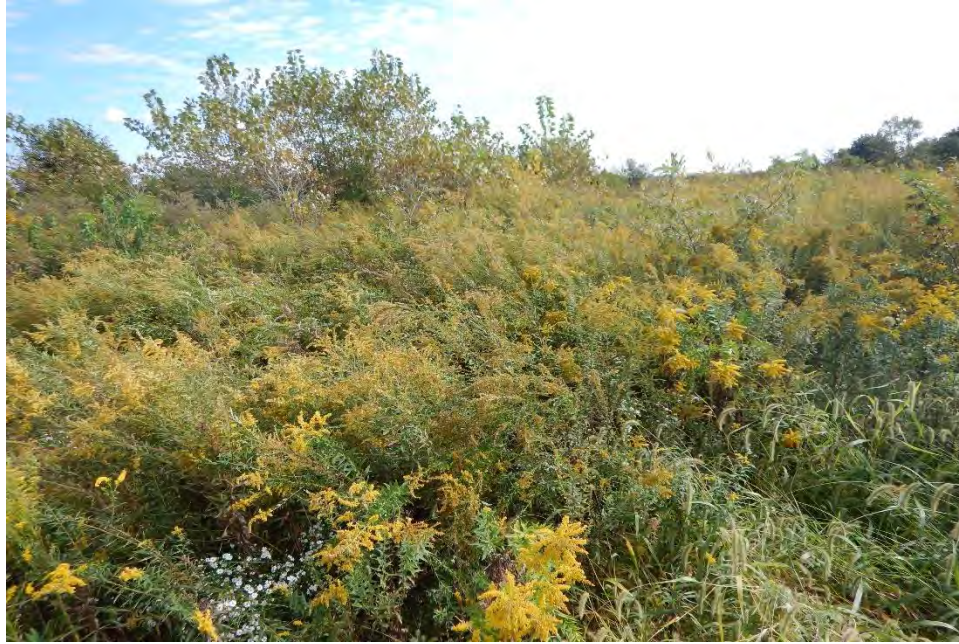
Photograph 33. Wetland area on the eastern side of SGH. Several white-tail deer beds were observed in this location. Area 13 on Figure 4, view to the east.

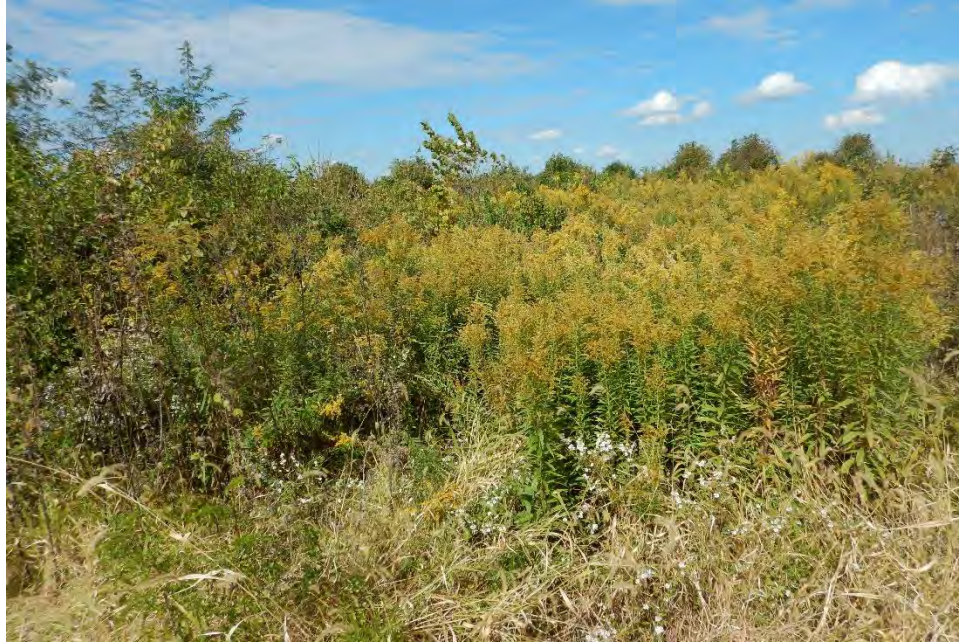
Photograph 34. Wetland area on the eastern side of SGH. Area 13 on Figure 4, view to the north.

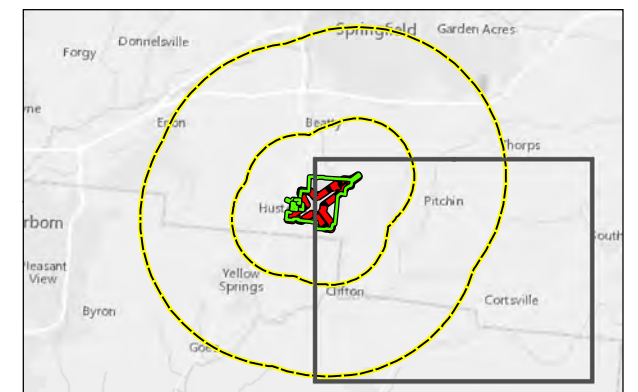
- Air Operations Area (AOA)
- Airport property boundary
- 5-mile buffer per AC150/5200-33A
- 10,000-ft buffer per AC150/5200-33A

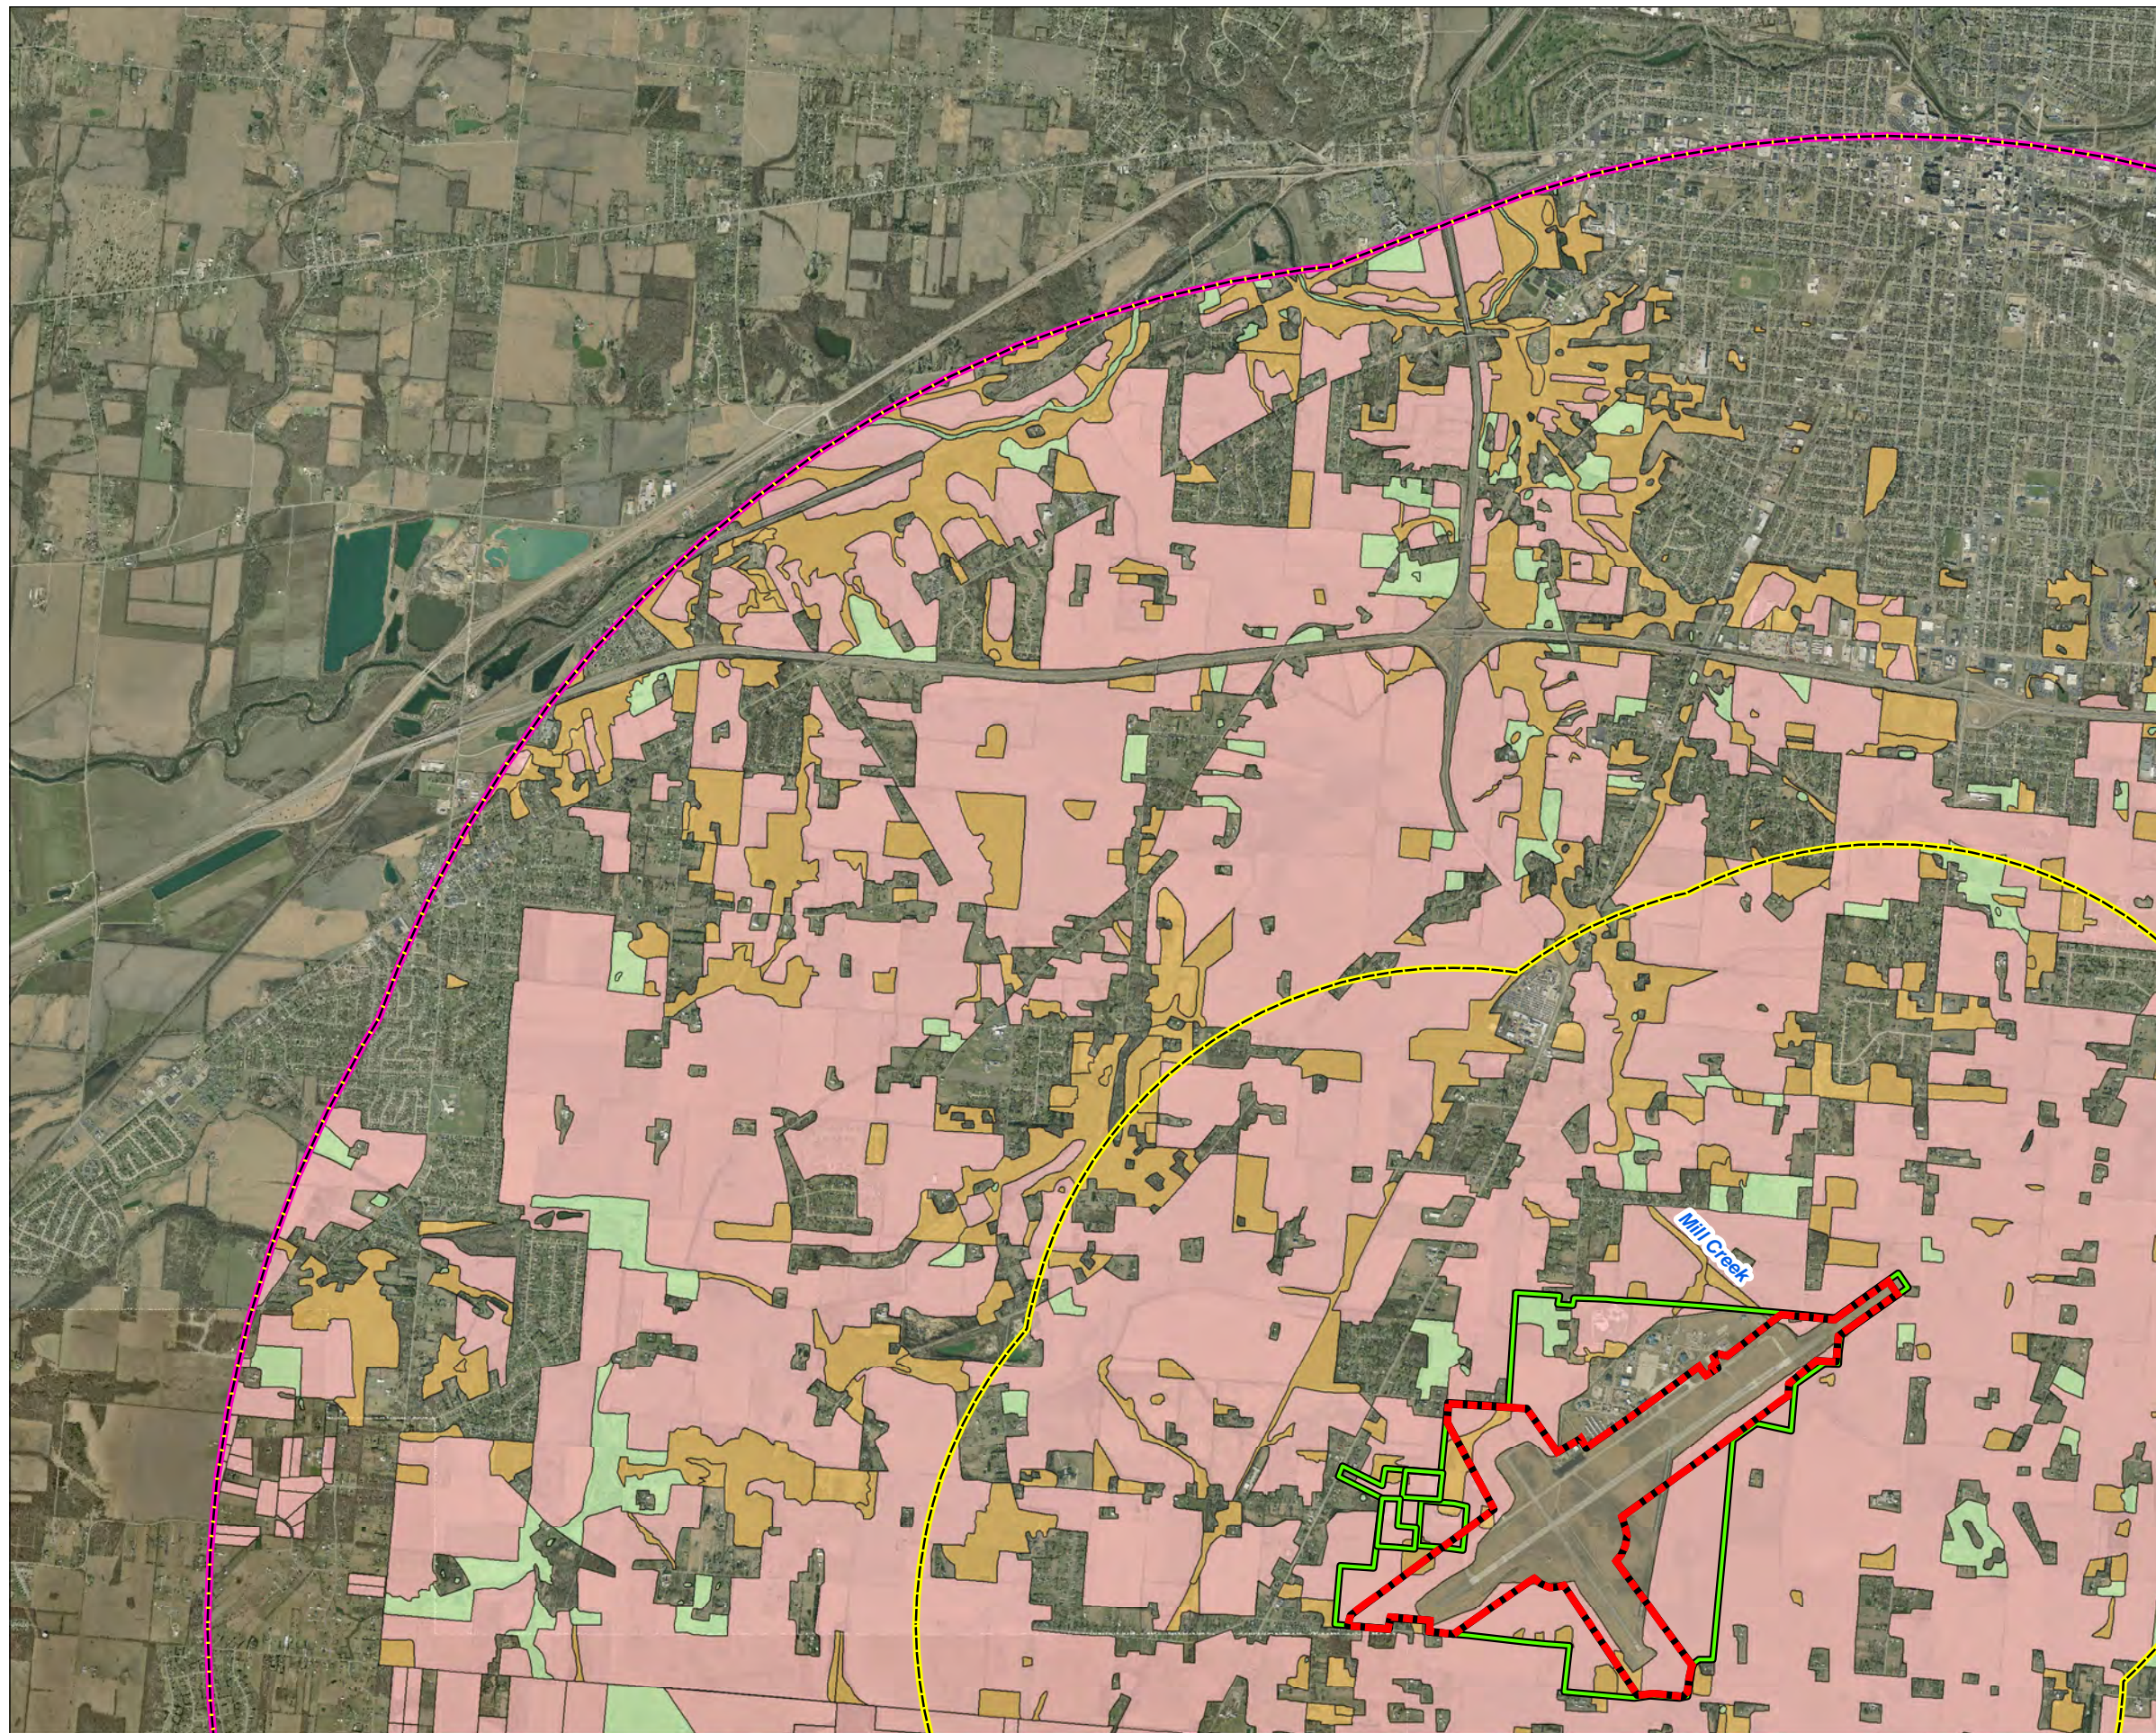
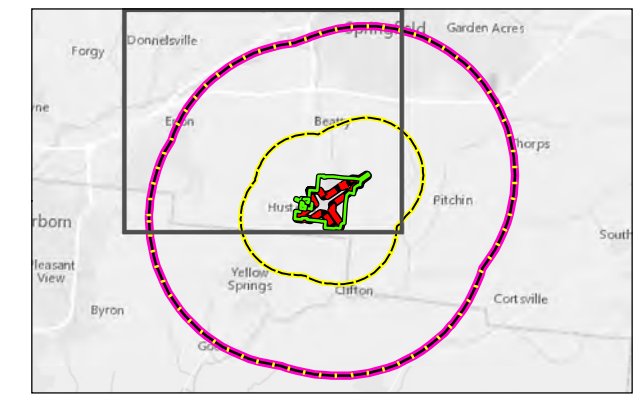
Portions of the ODOT Clark and Greene counties highway maps showing the Springfield-Beckley Municipal Airport and 5-mile General Separation Criteria boundary for hazardous wildlife attractants.

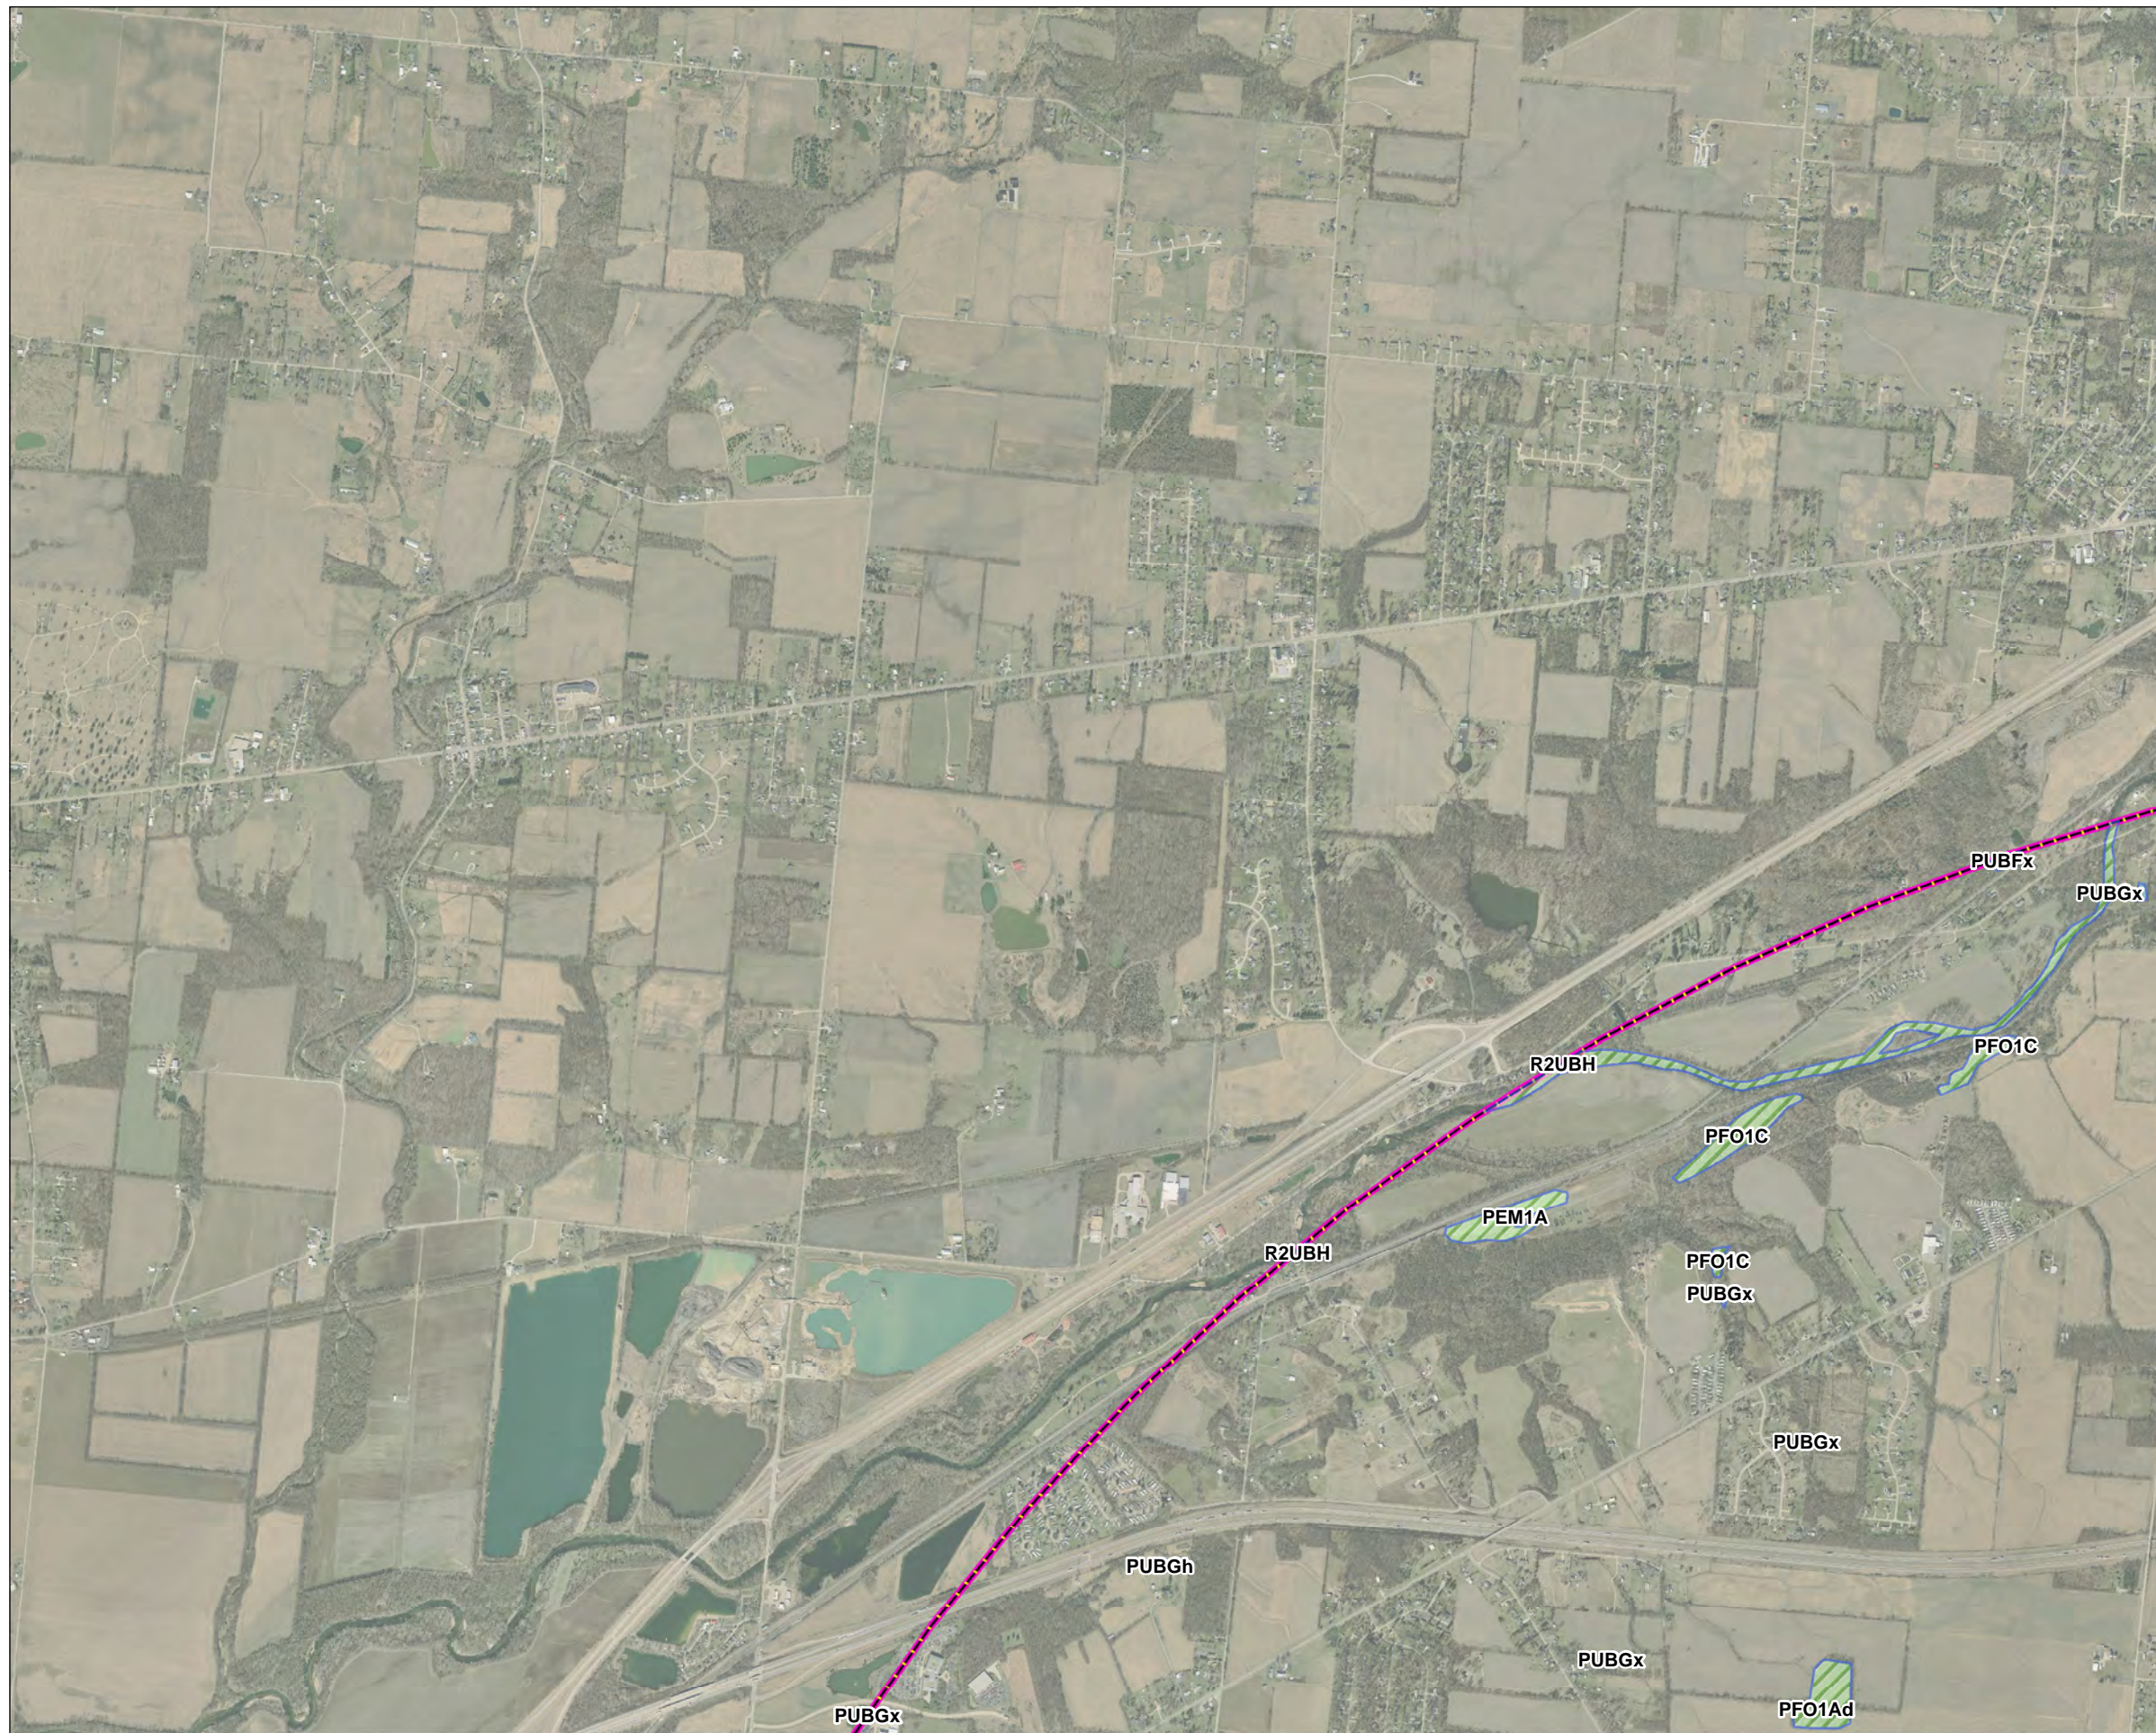
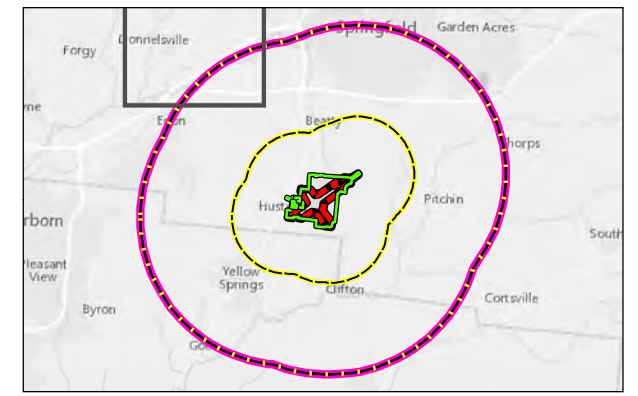
- 5-mile buffer*
- Wetland
- Pond/Lake

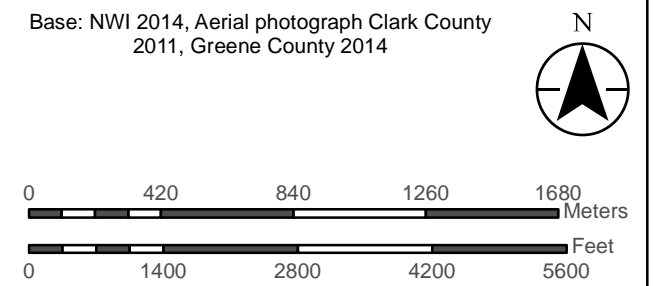
Figure 6 **Sheet 1 of 12**

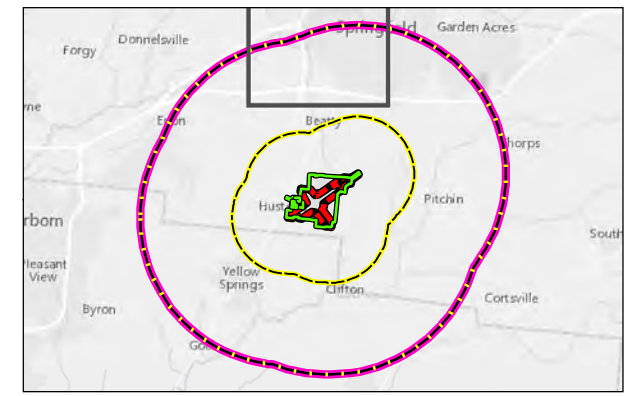
- 5-mile buffer*
- Wetland
- Pond/Lake

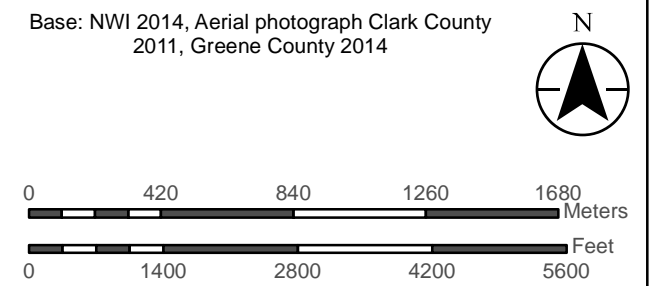
Figure 6 **Sheet 2 of 12**

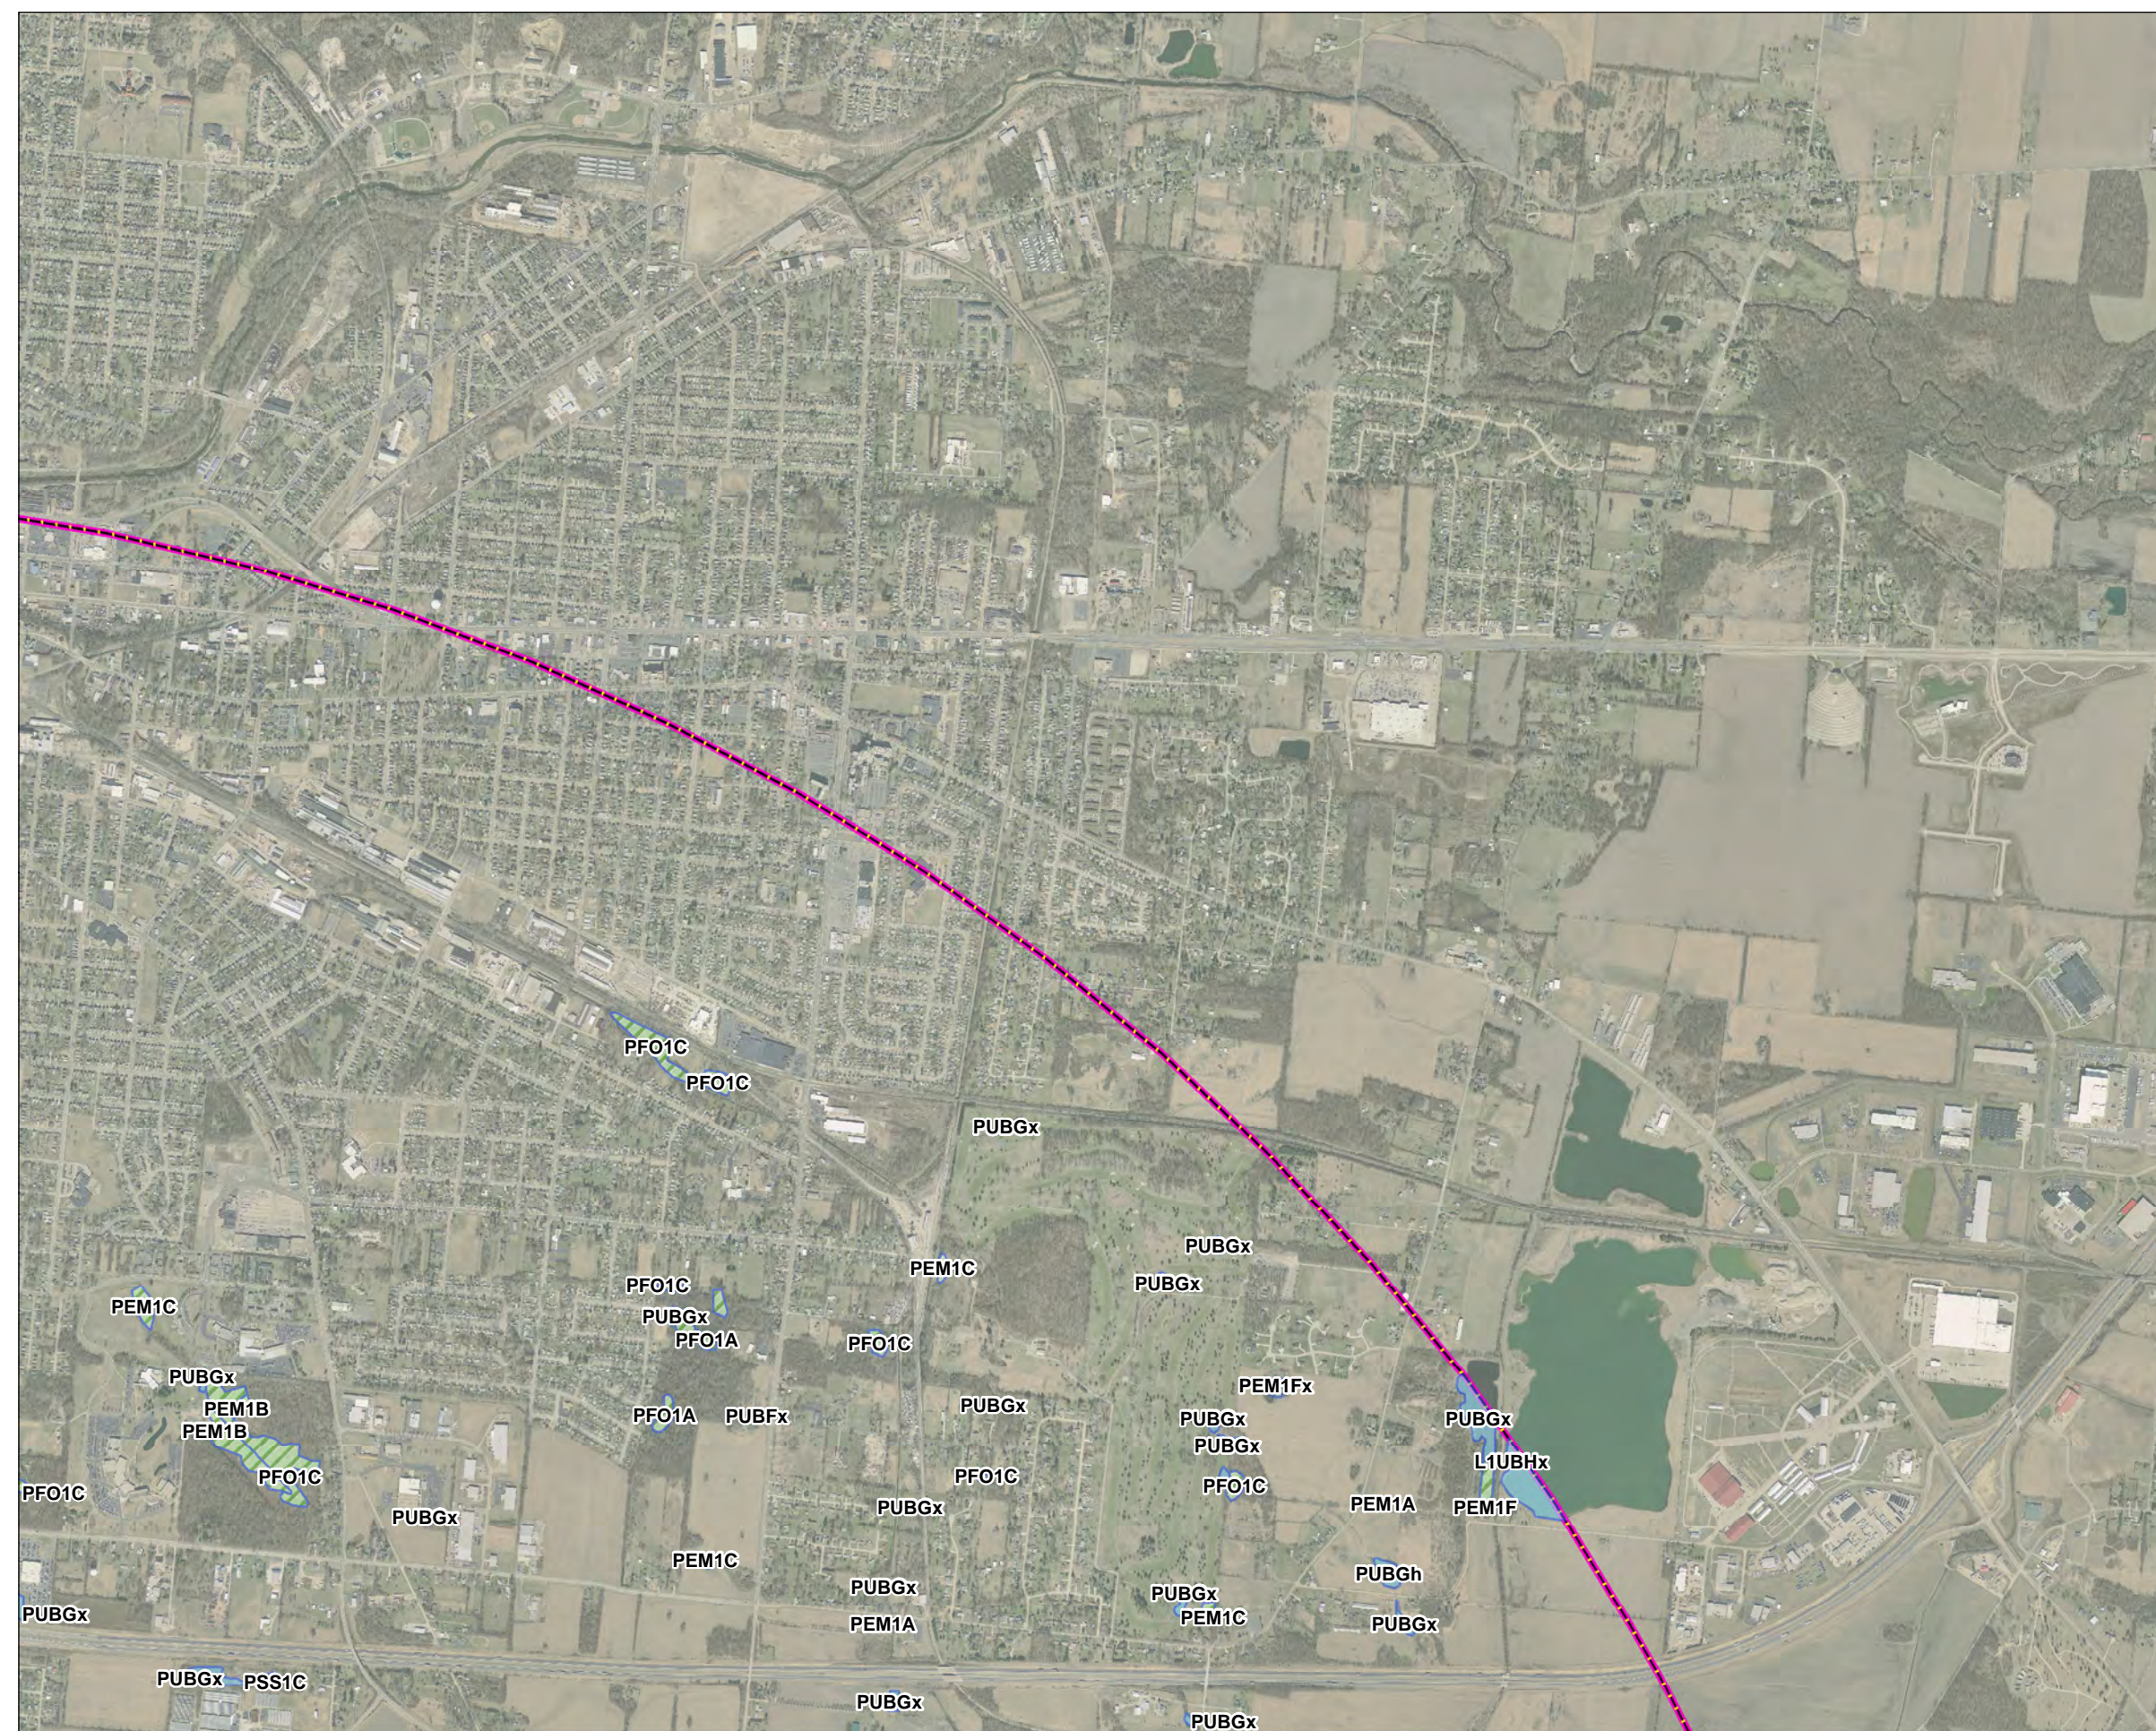
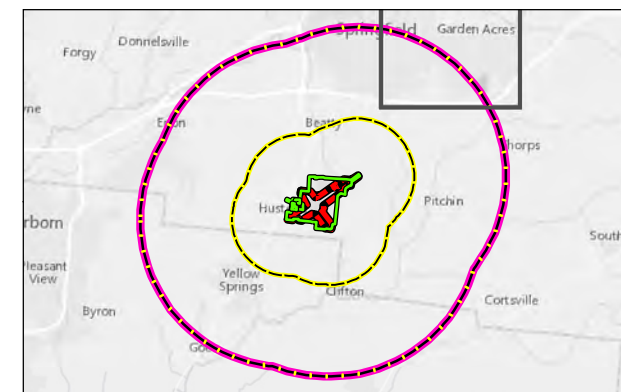
Portions of the Clark and Greene counties, Ohio National Wetland Inventory (NWI) map (USFWS 2014 and 2011) showing the Springfield-Beckley Municipal Airport and the General Separation Criteria for hazardous wildlife attractants perimeters. (12 sheets)

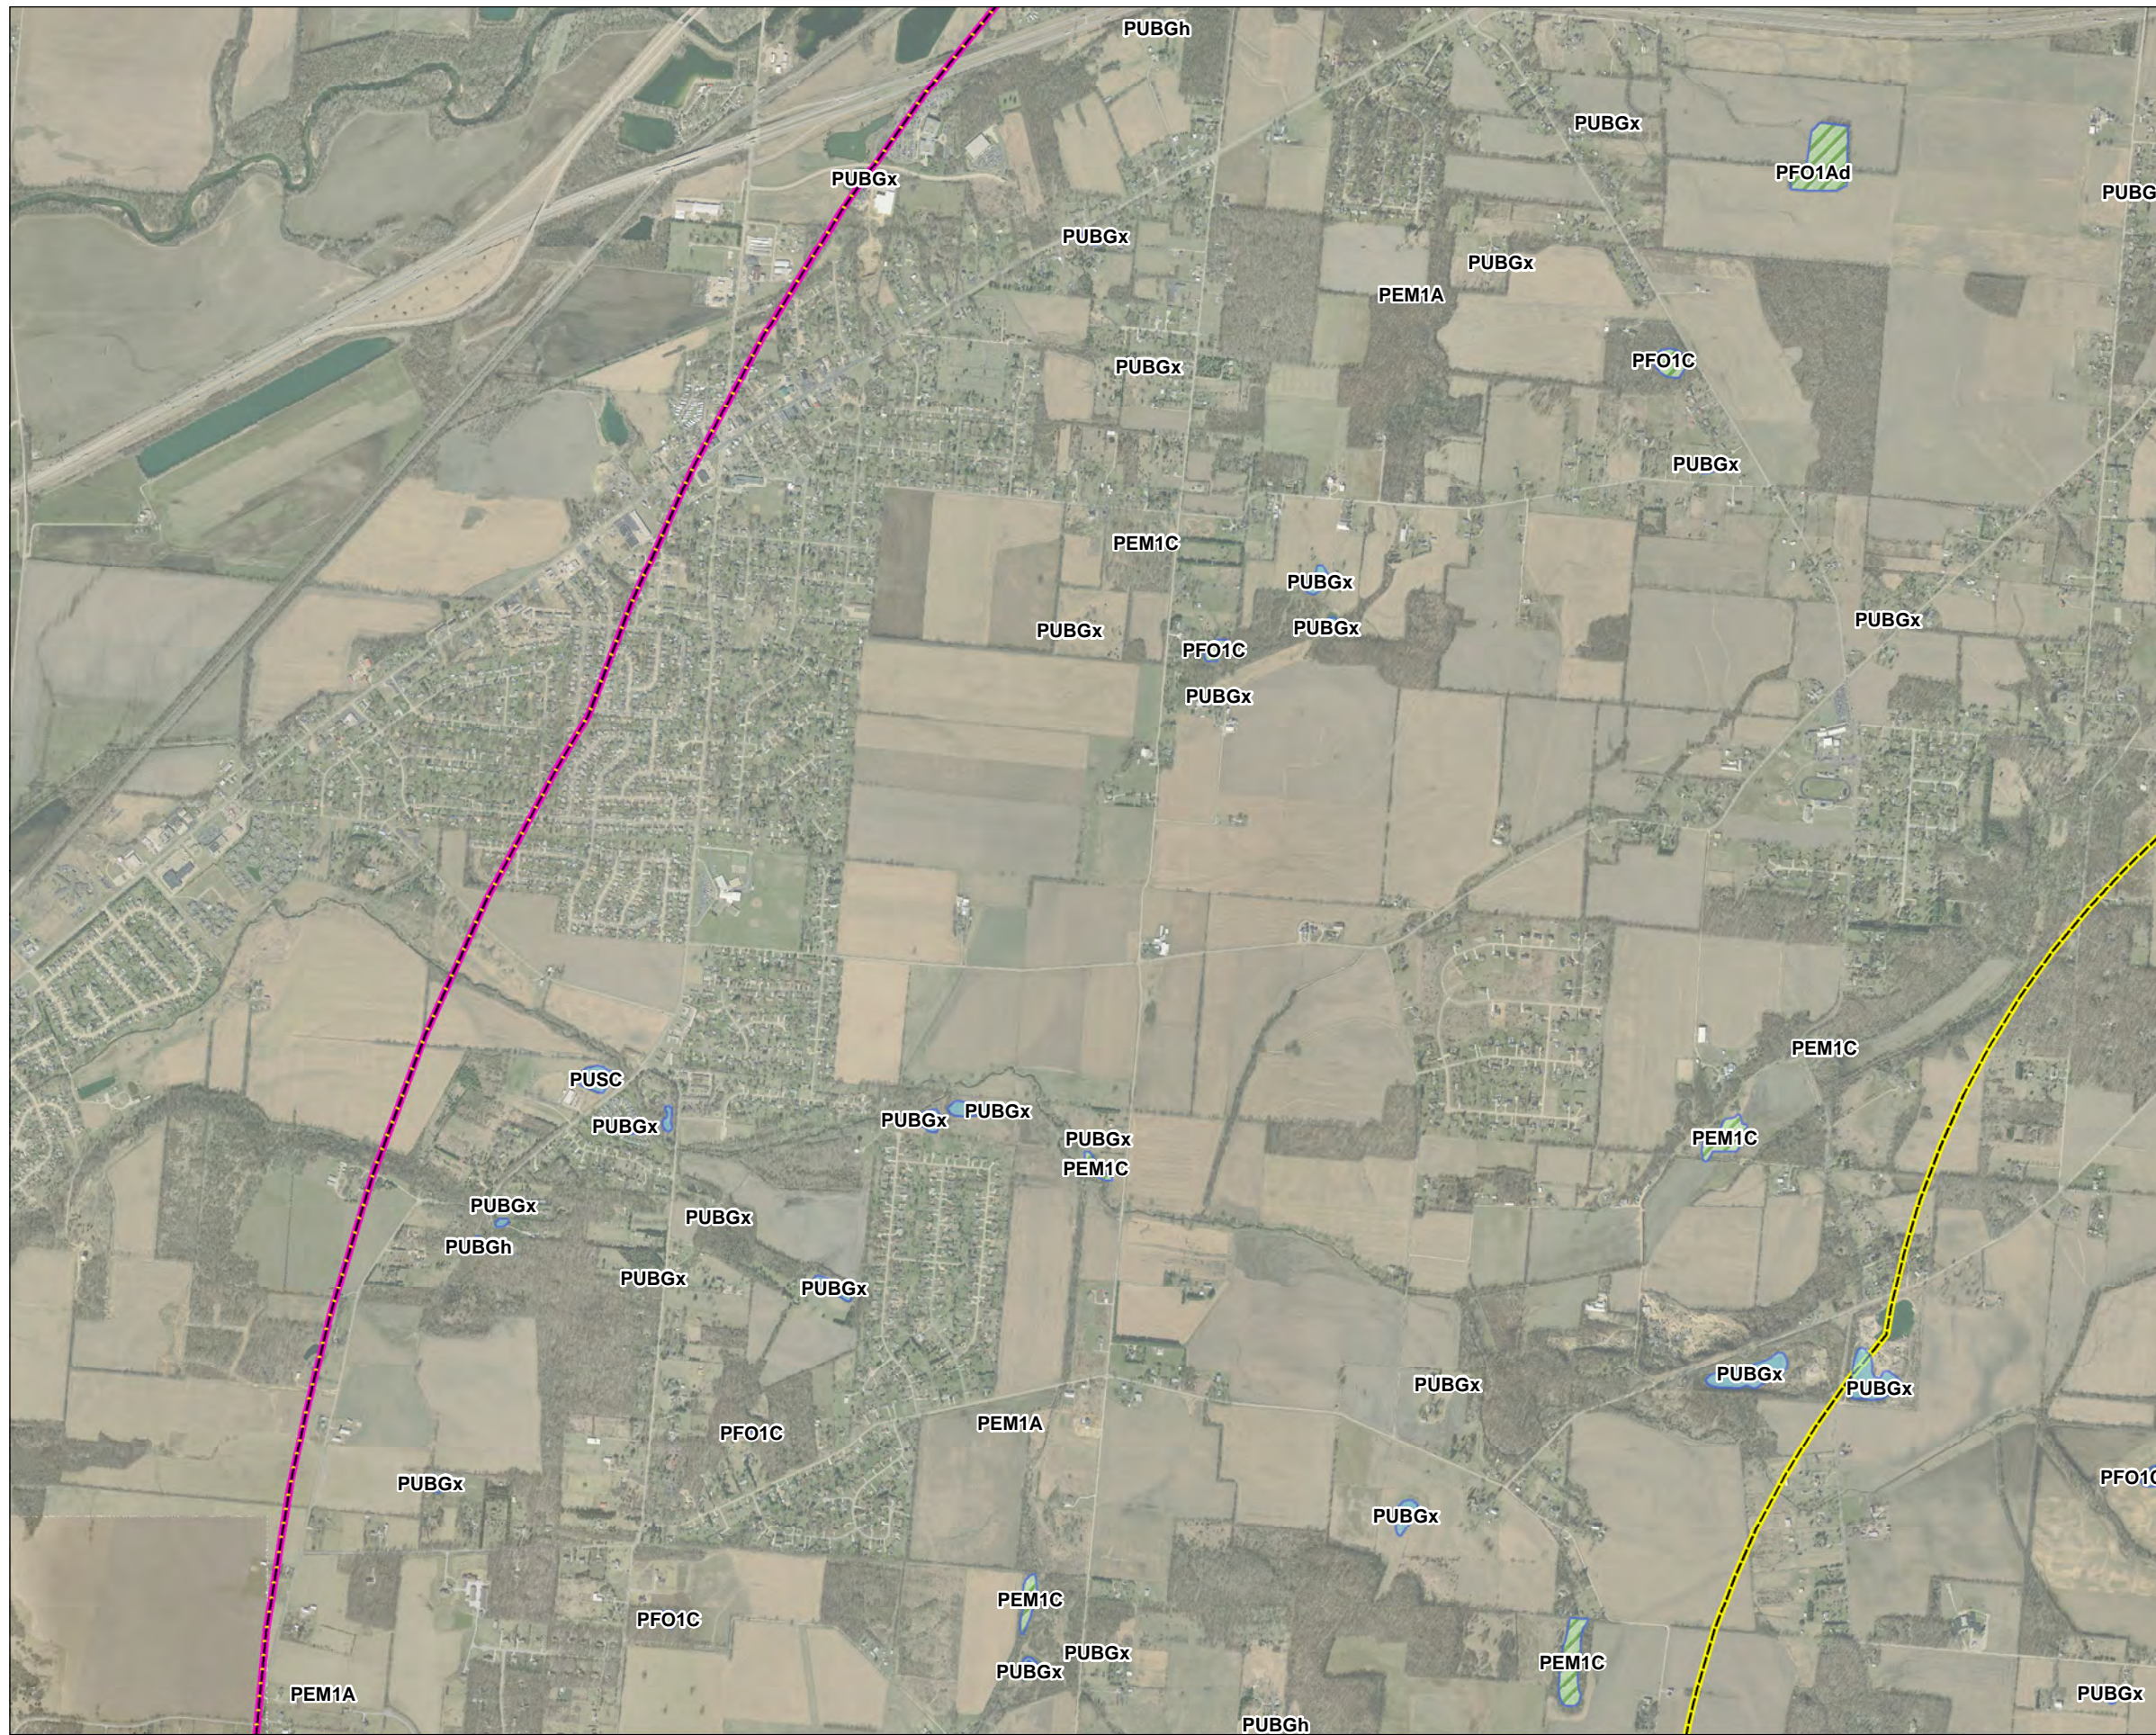
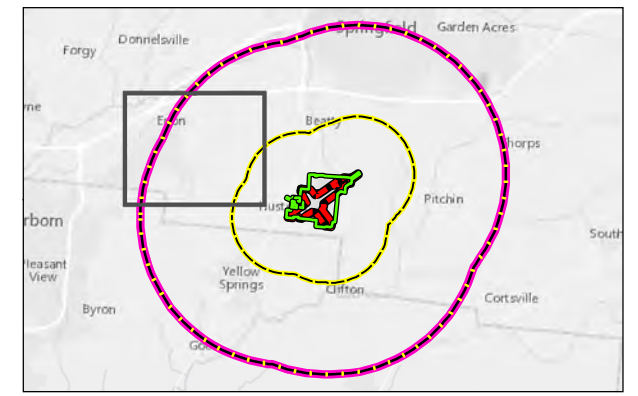
- 5-mile buffer*
- 10,000-ft buffer*
- Wetland
- Pond/Lake

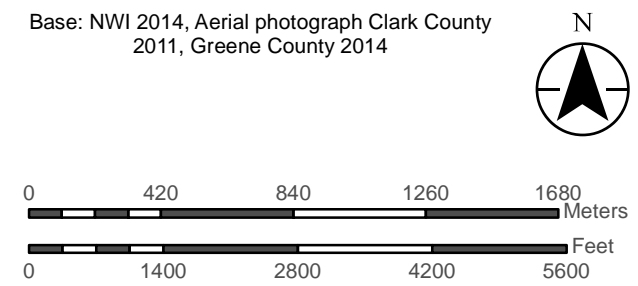
Figure 6 **Sheet 4 of 12**

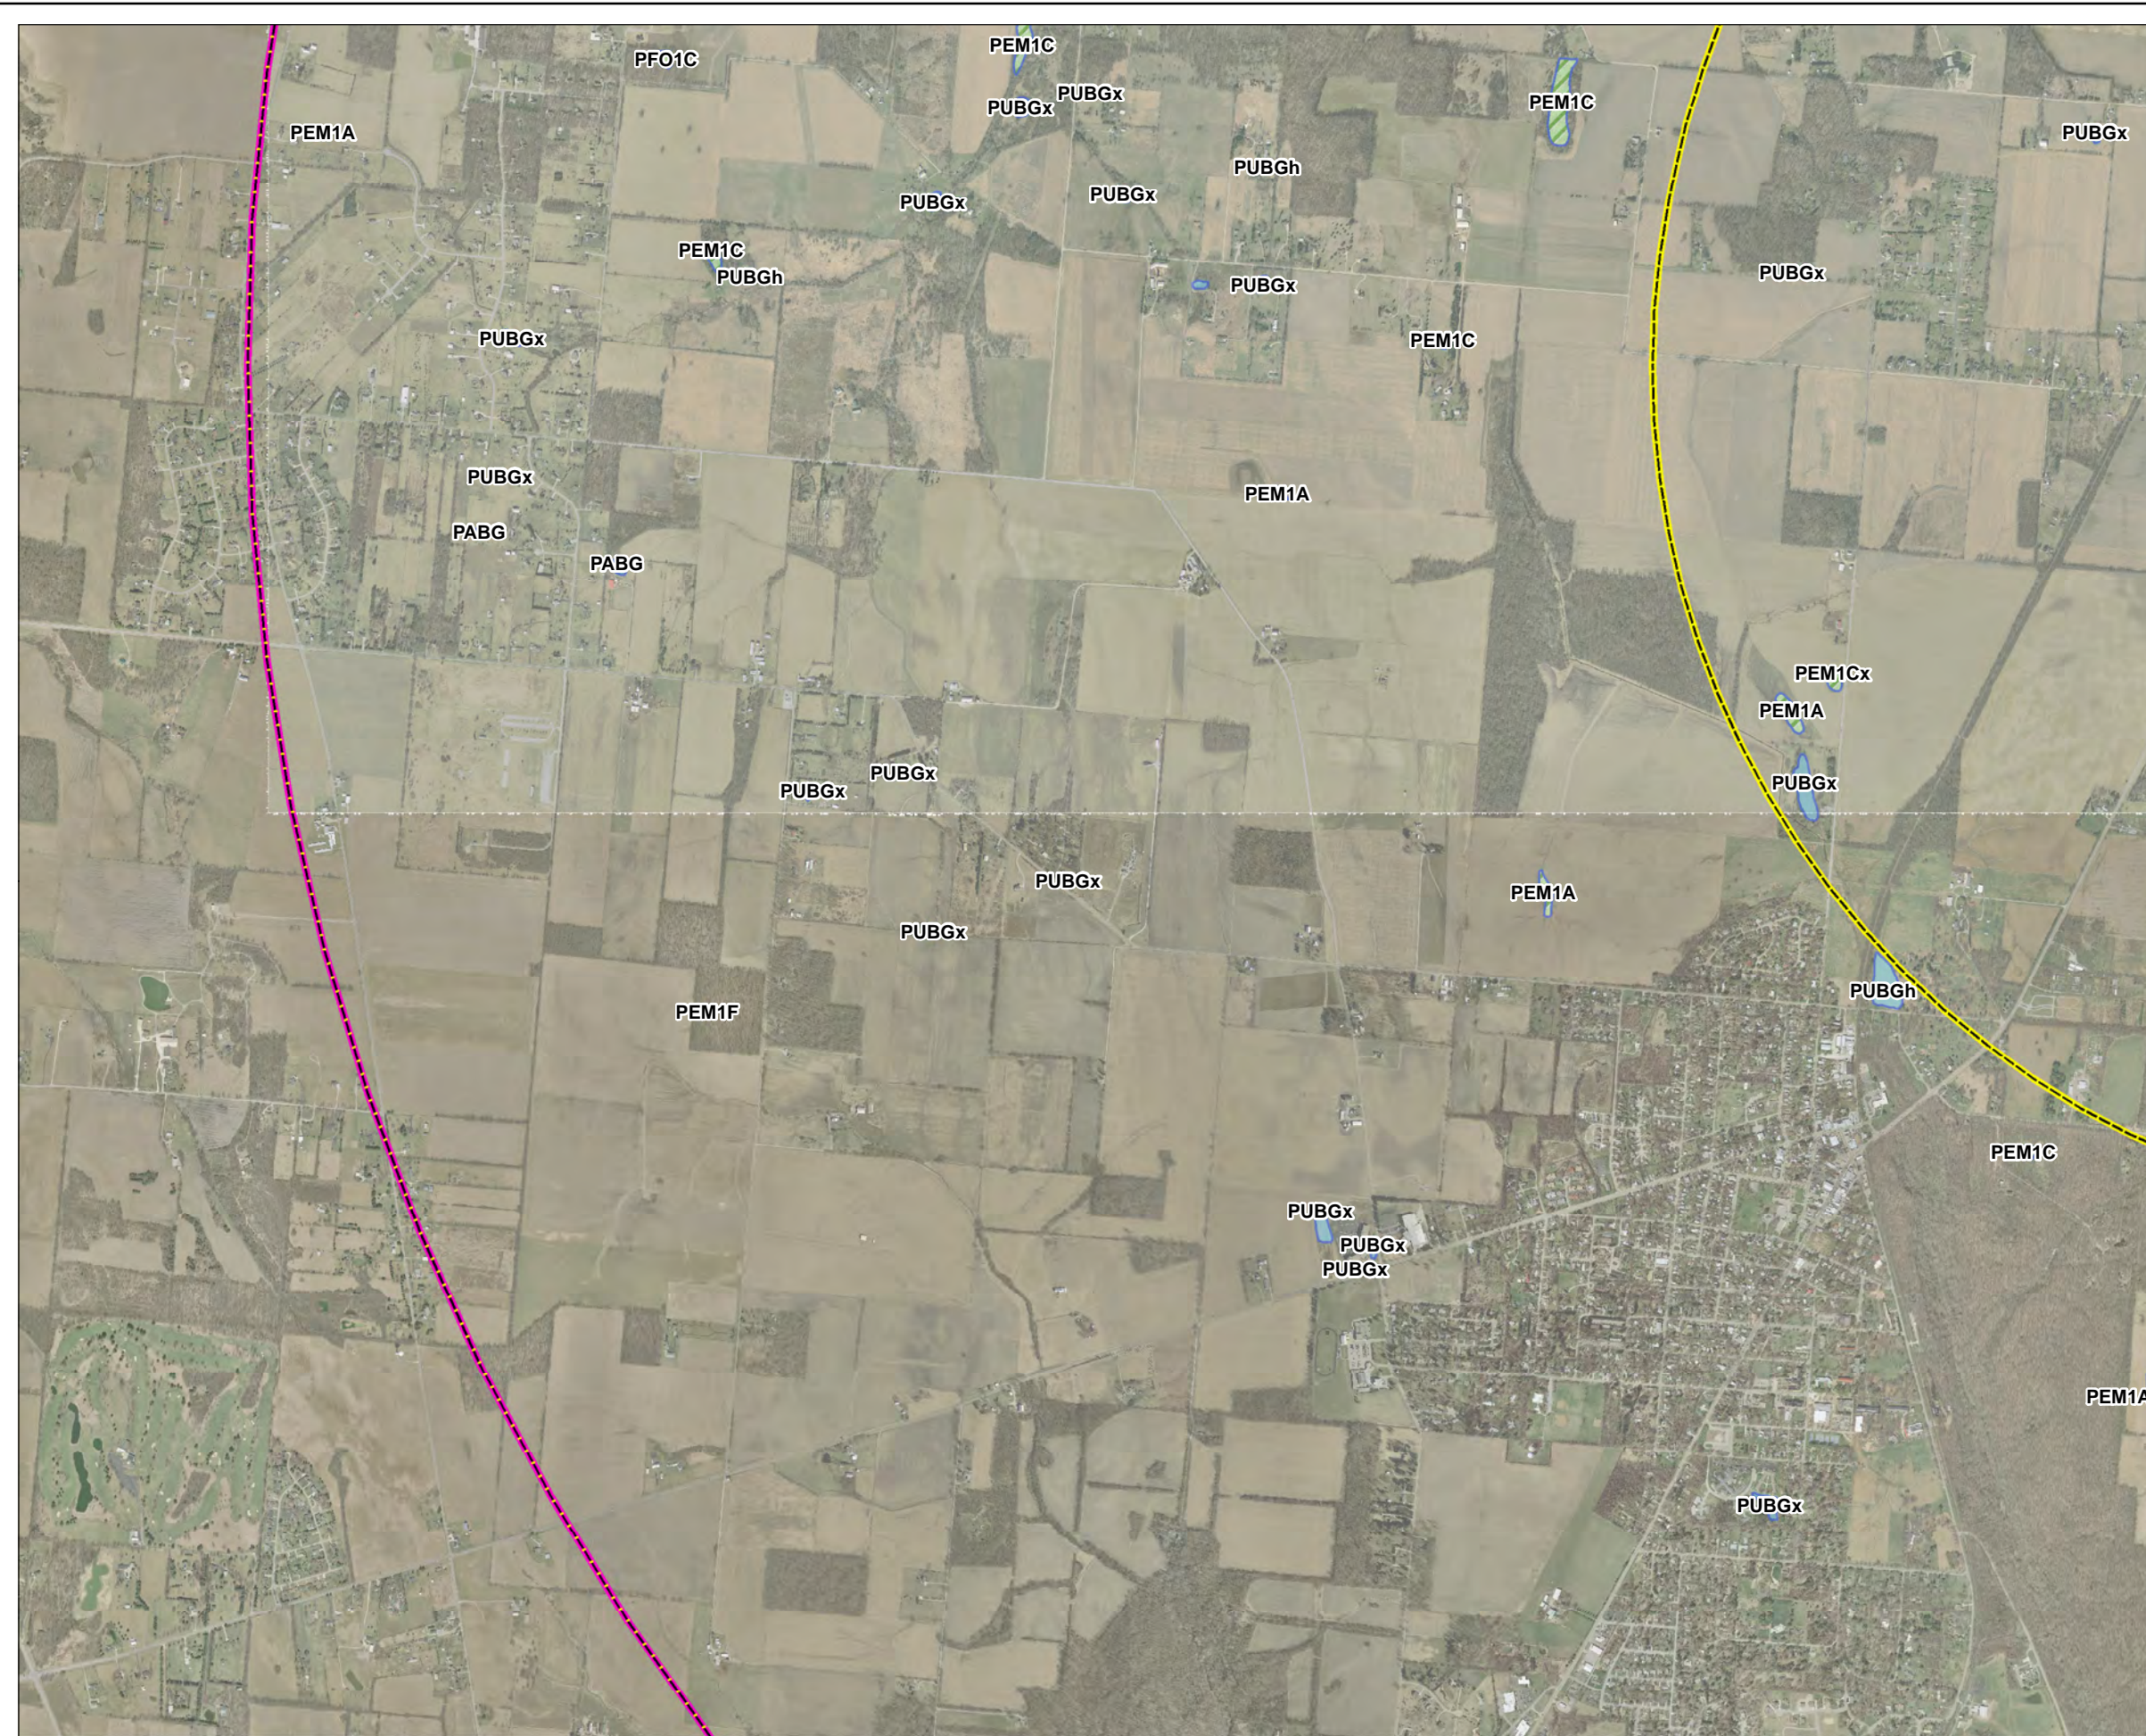
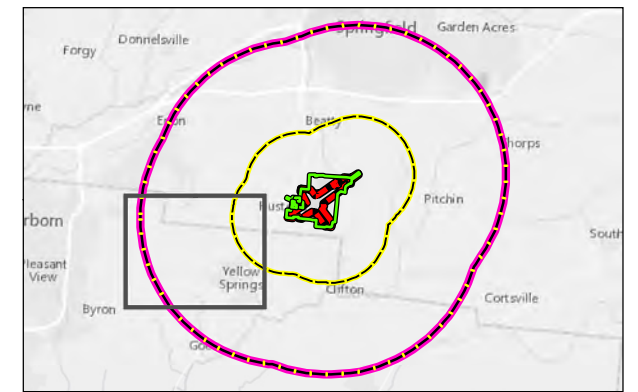
- 5-mile buffer*
- 10,000-ft buffer*
- Wetland
- Pond/Lake
