Appendix G – Wildlife Site Visit Report

Wildlife Hazard Site Visit

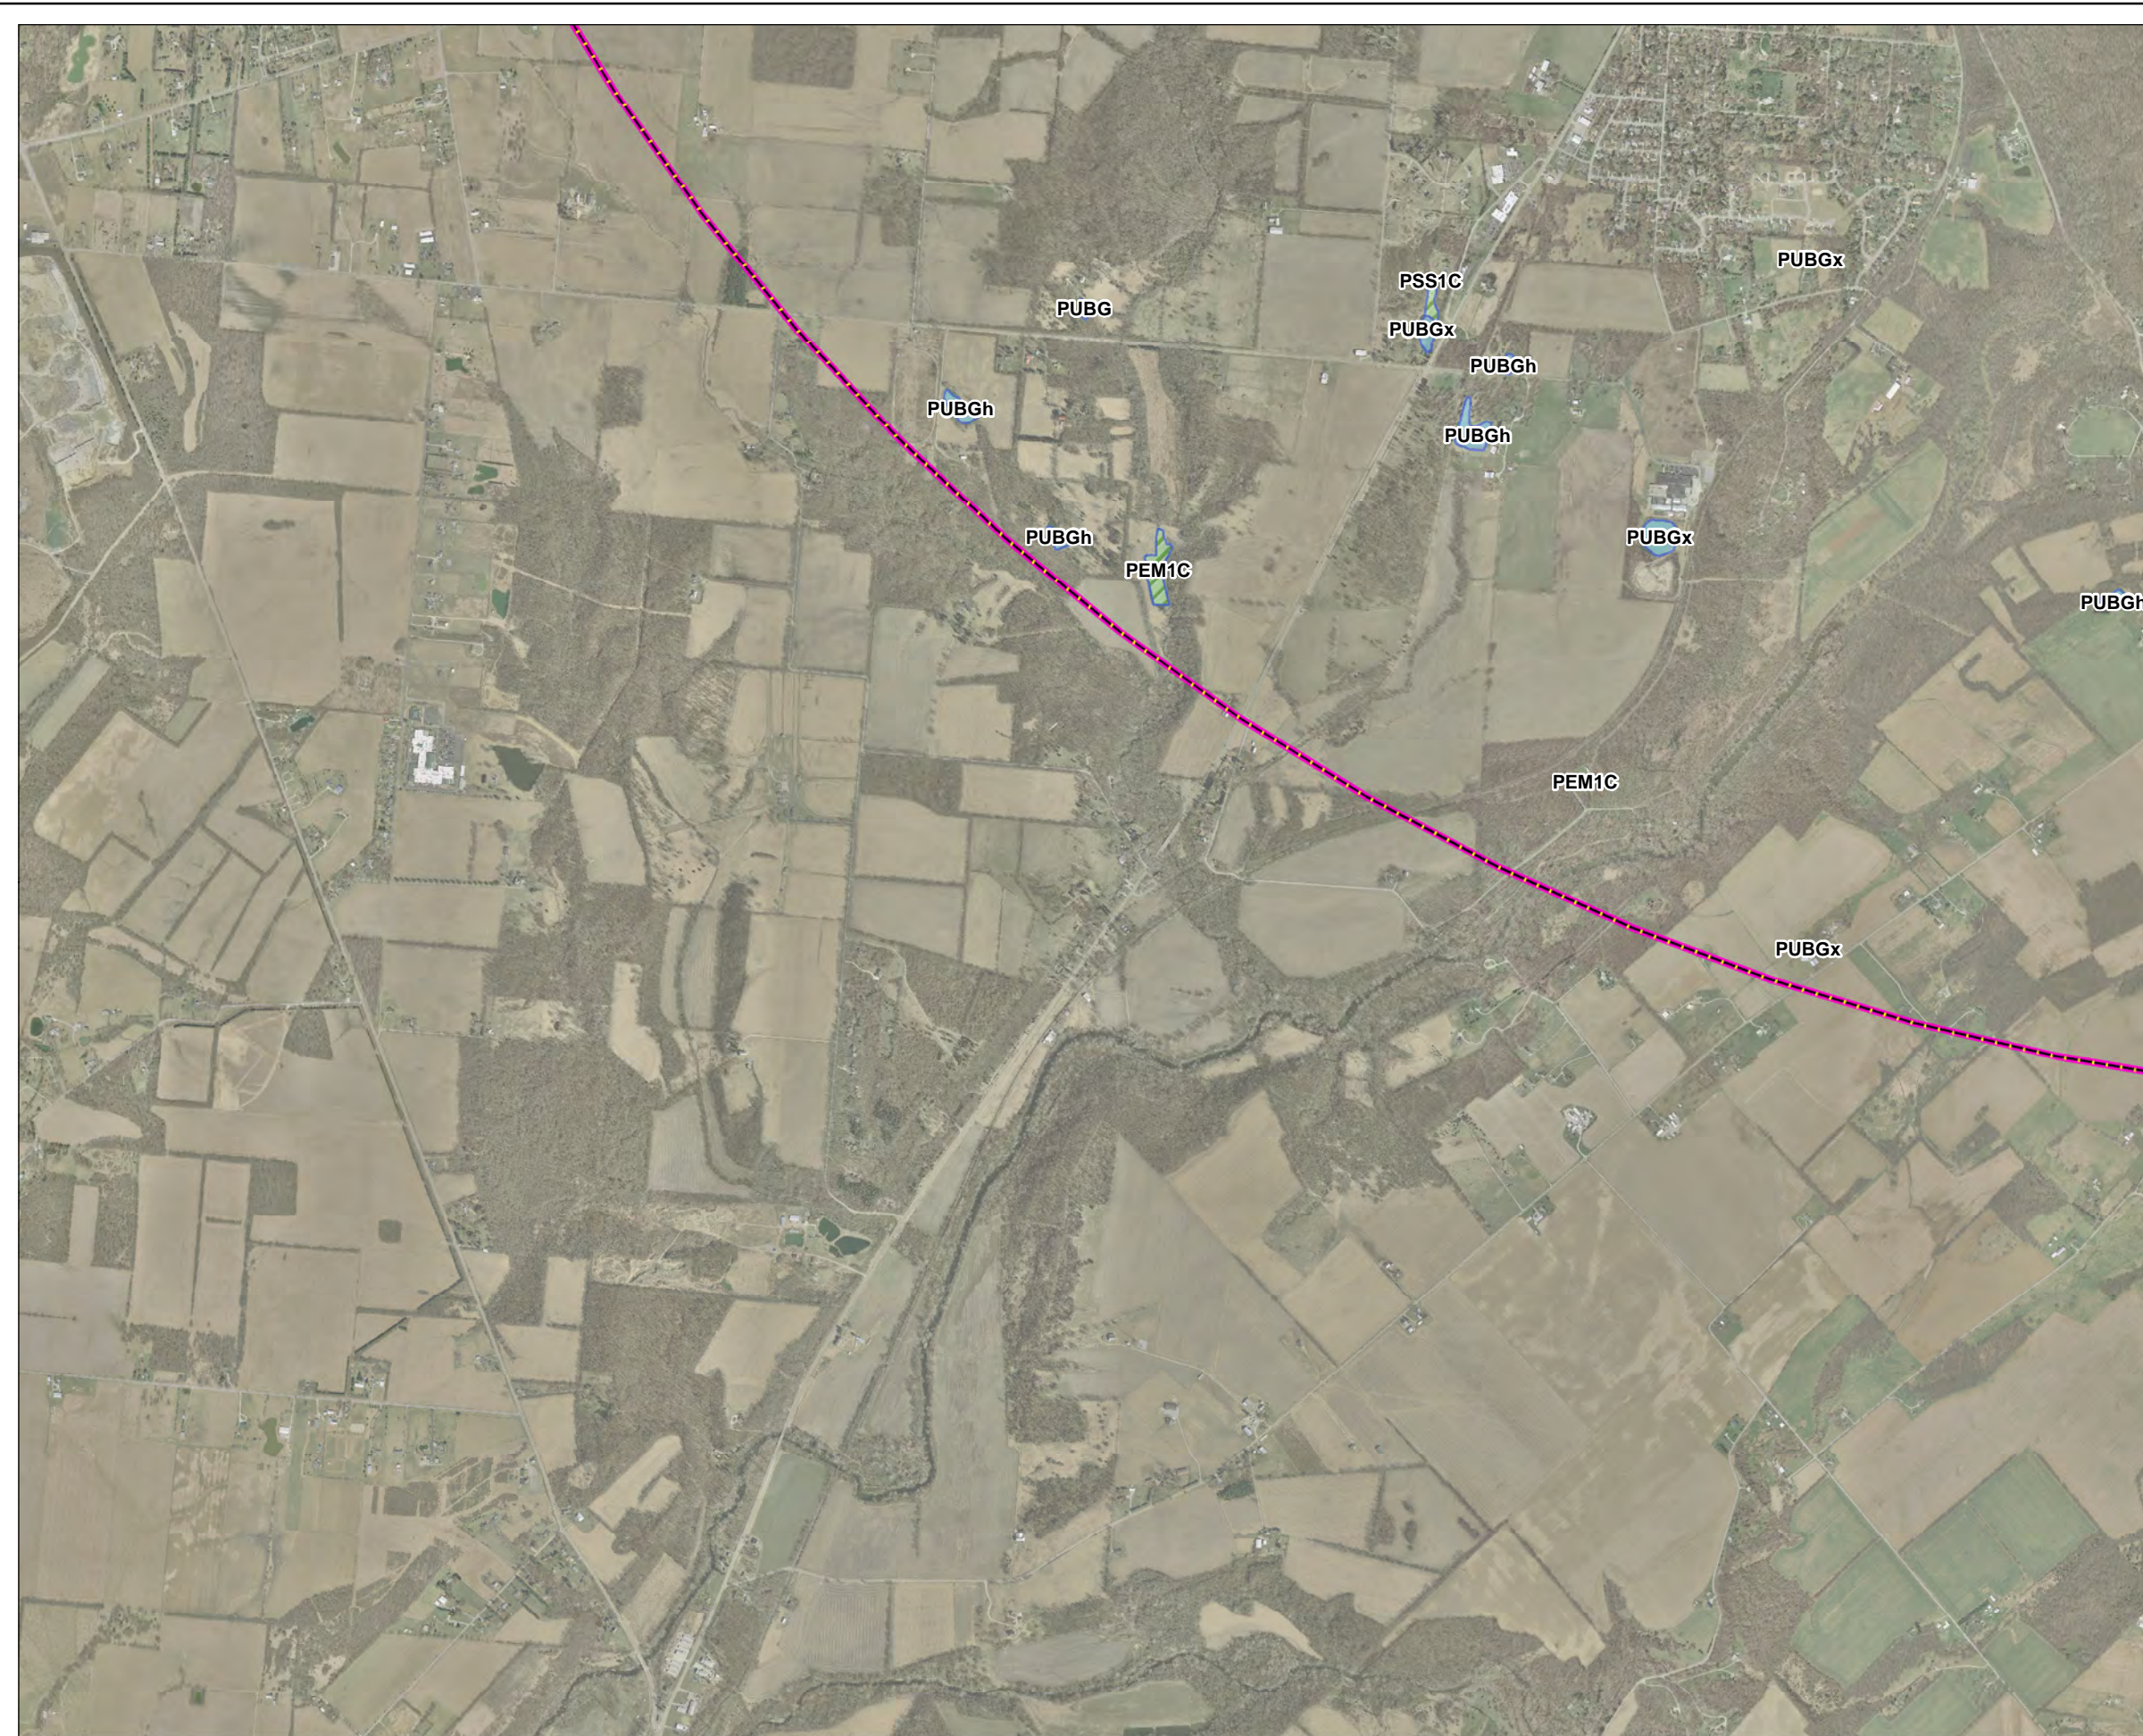
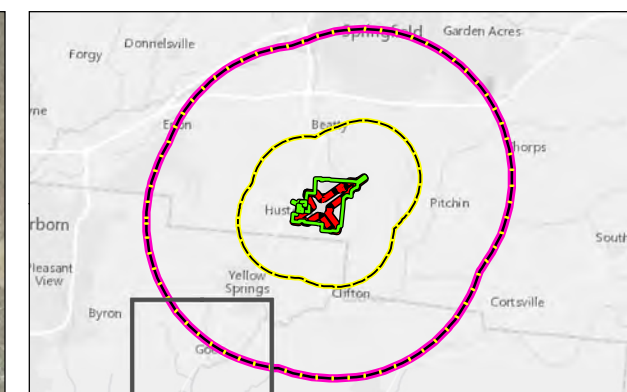
-   5-mile buffer*
-   Wetland
-   Pond/Lake

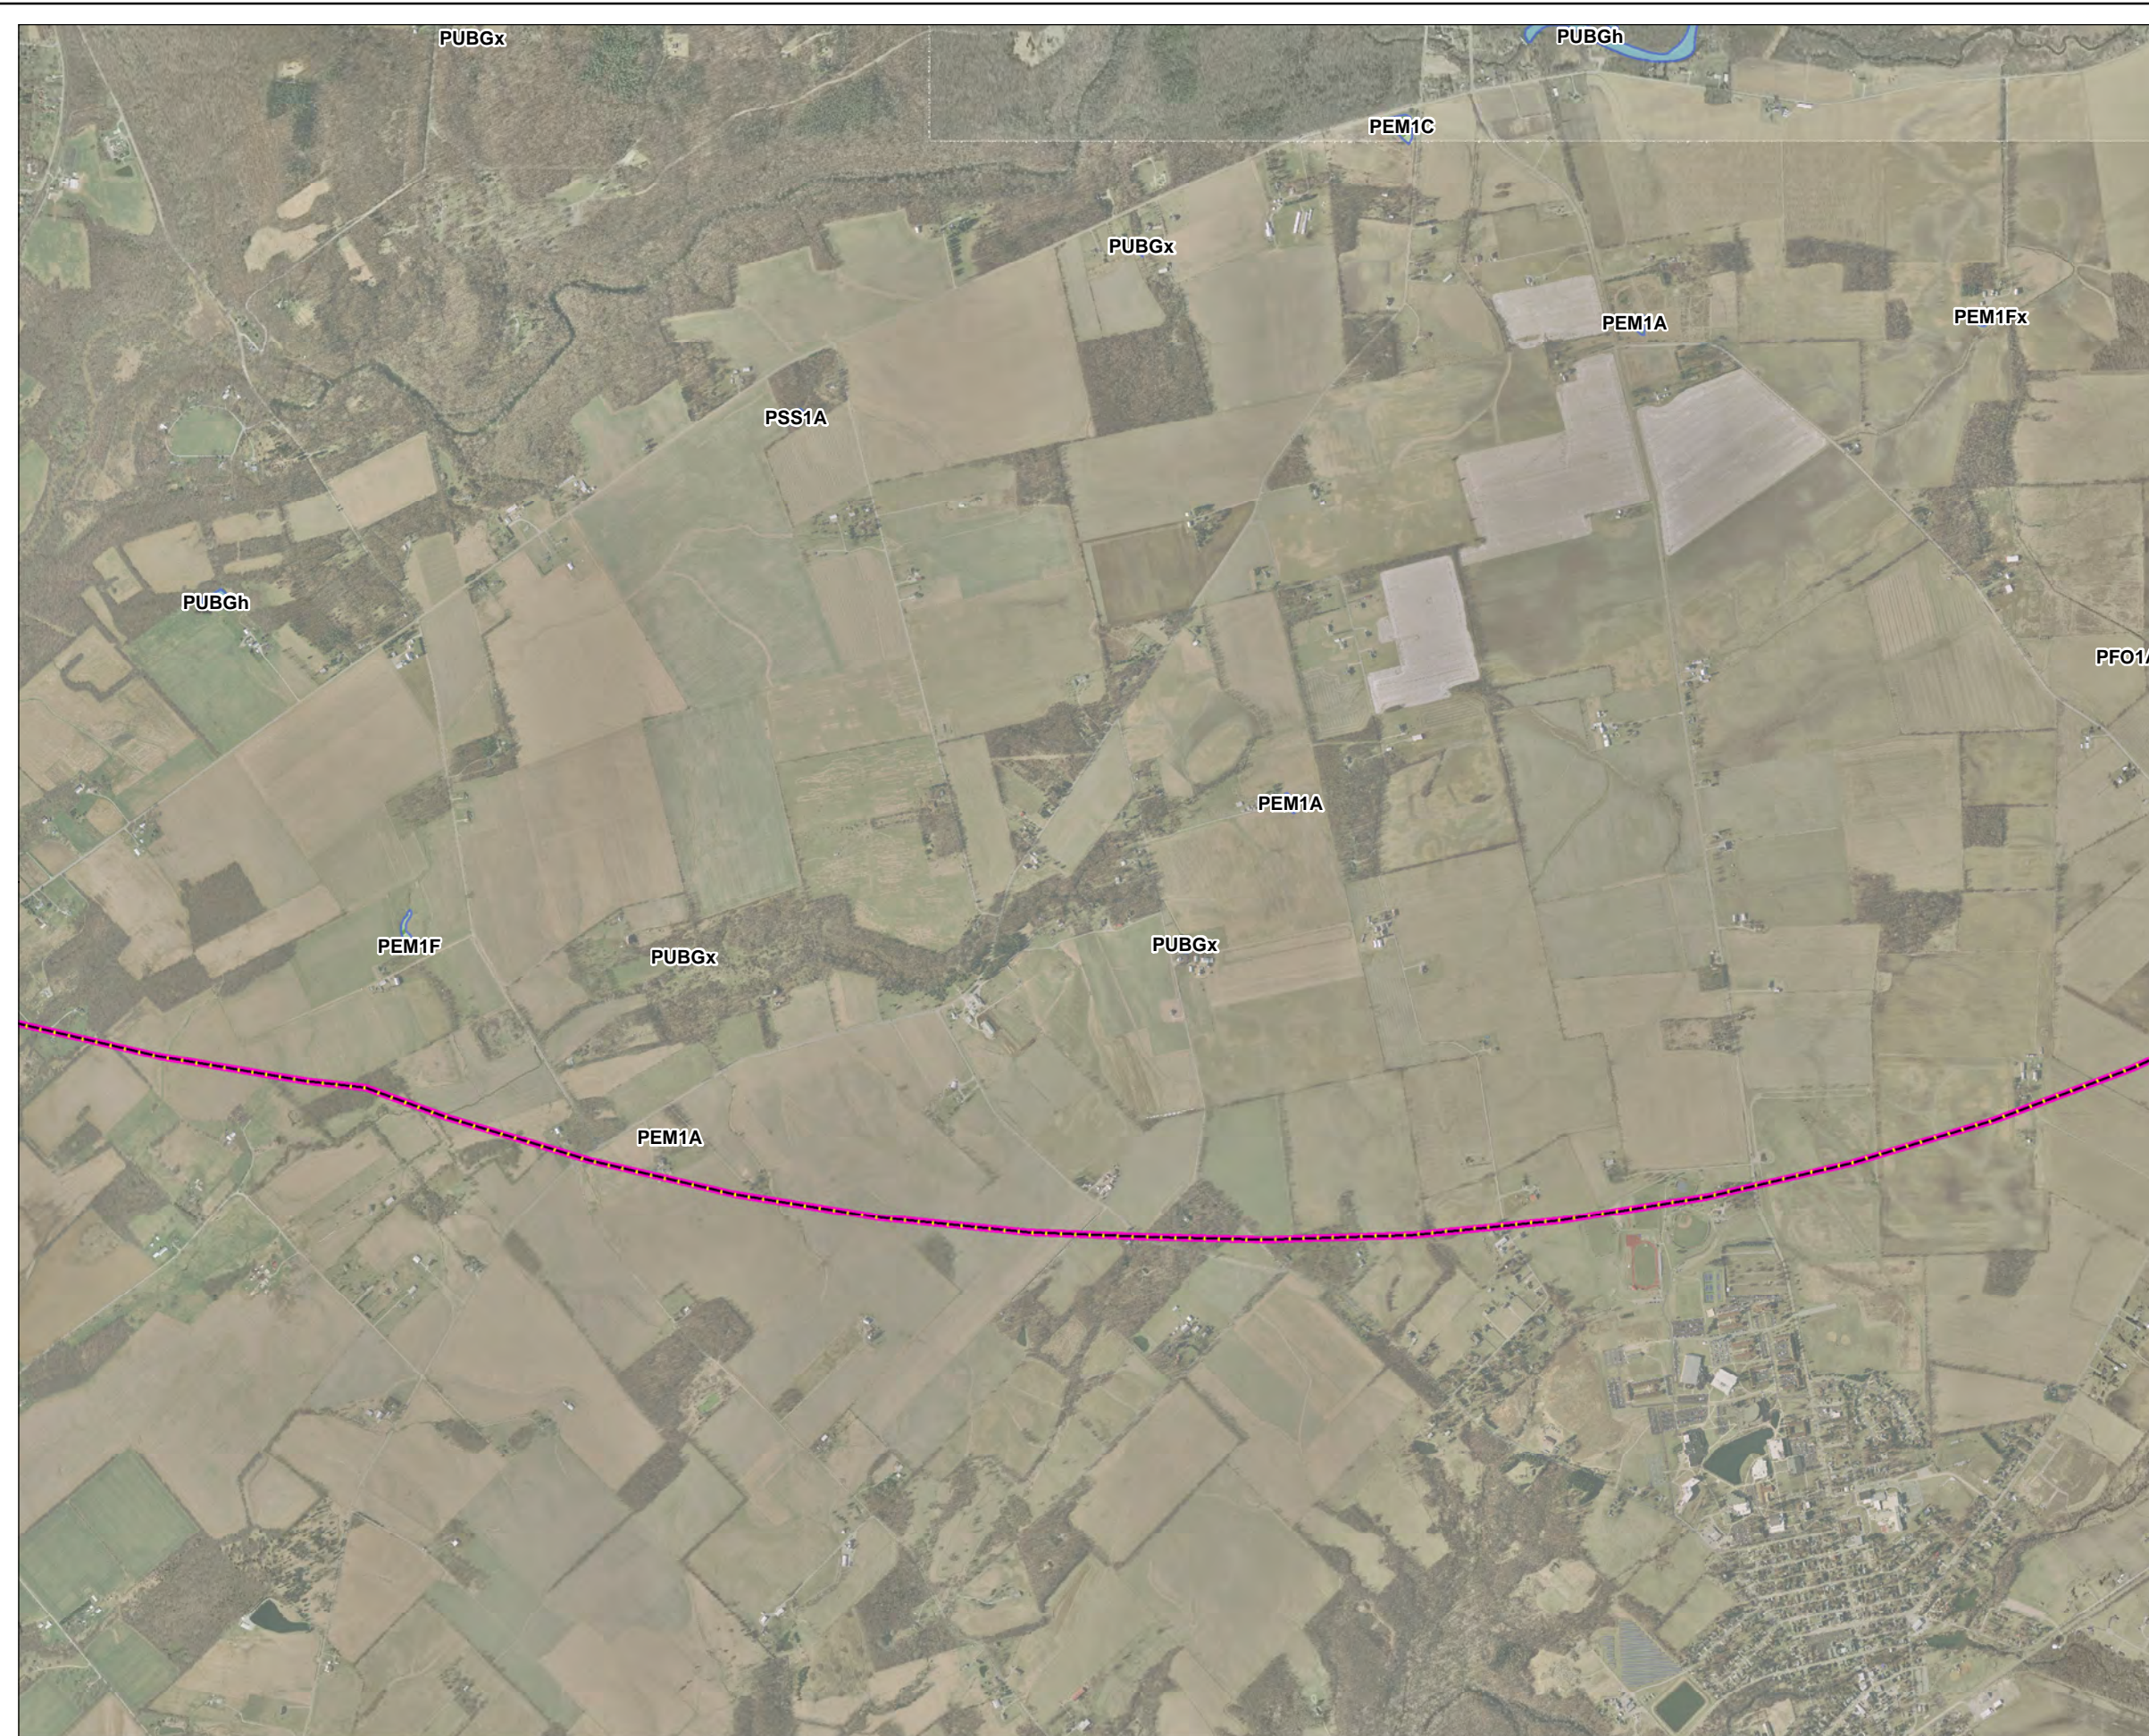
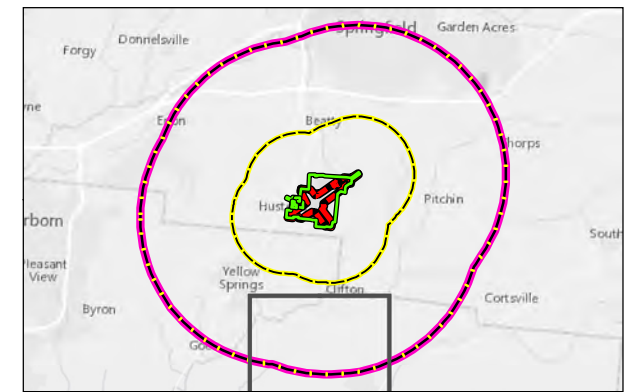
-   5-mile buffer*
-   Wetland
-   Pond/Lake

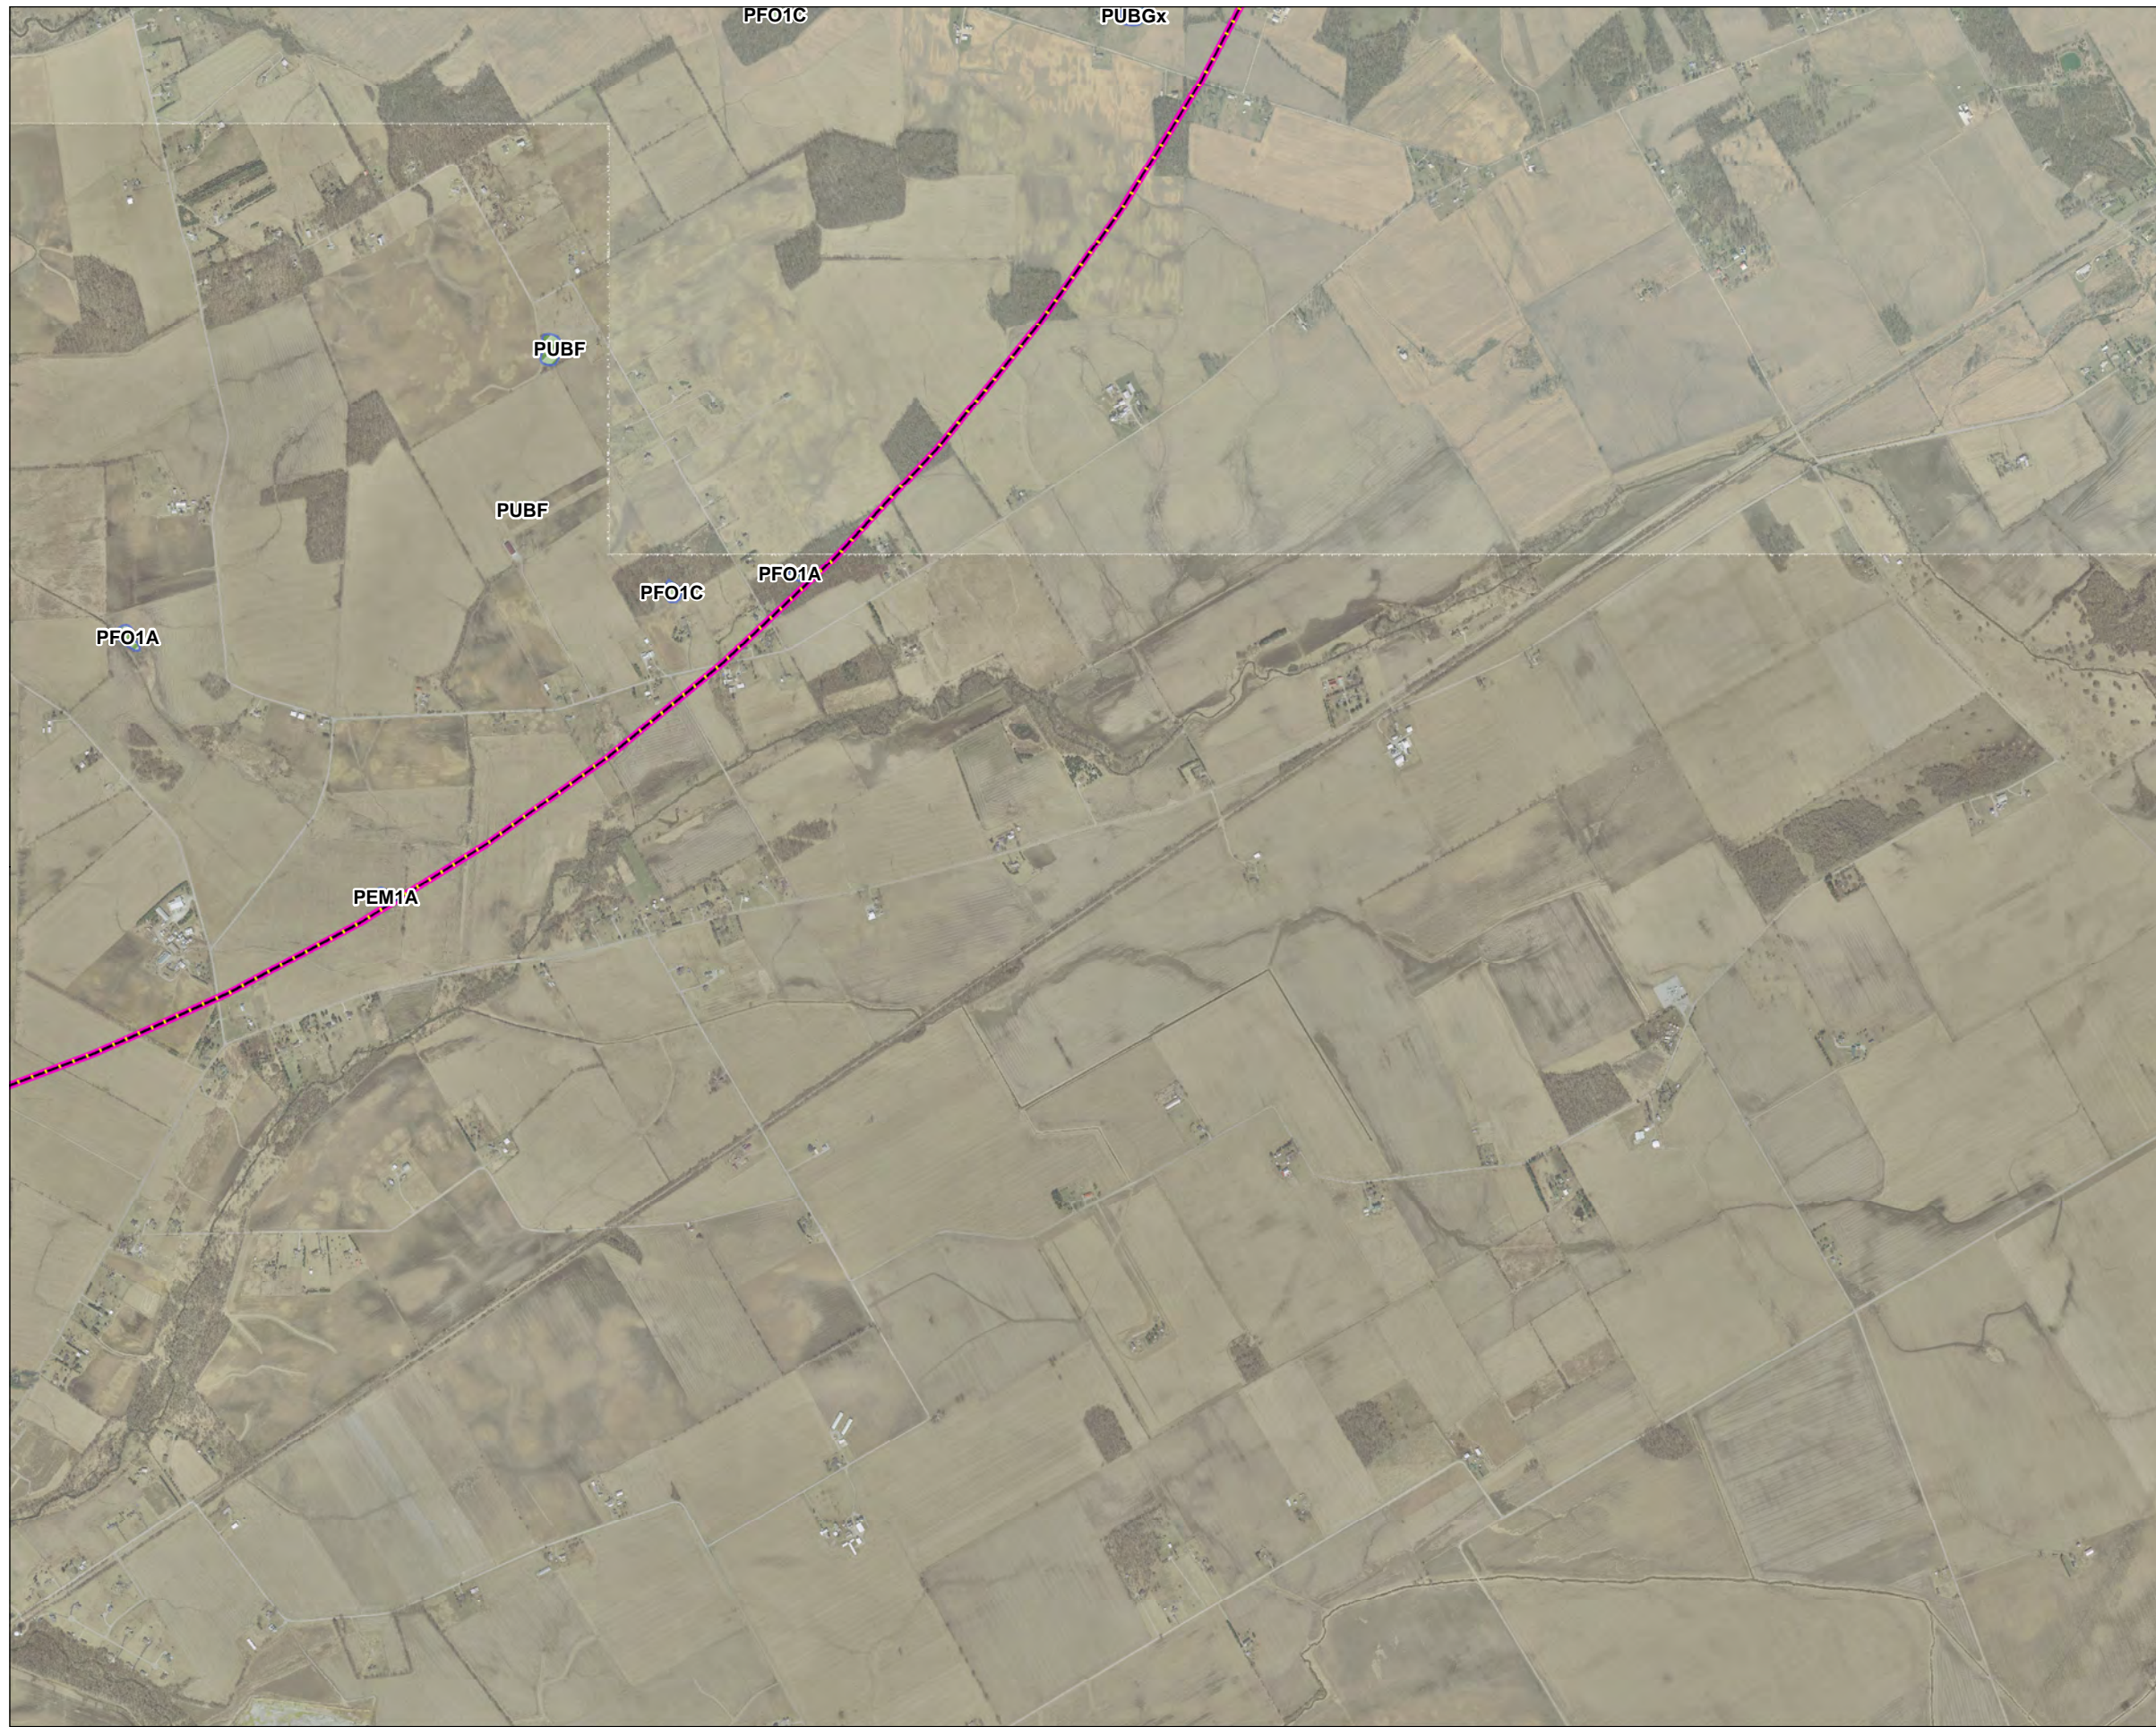
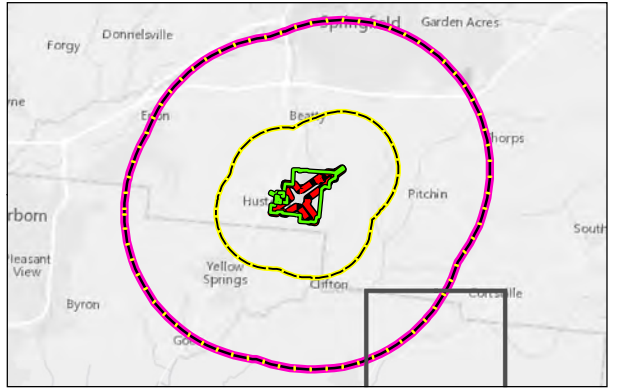
Portions of the Clark and Greene counties, Ohio National Wetland Inventory (NWI) map (USFWS 2014 and 2011) showing the Springfield-Beckley Municipal Airport and the General Separation Criteria for hazardous wildlife attractants perimeters. (12 sheets)

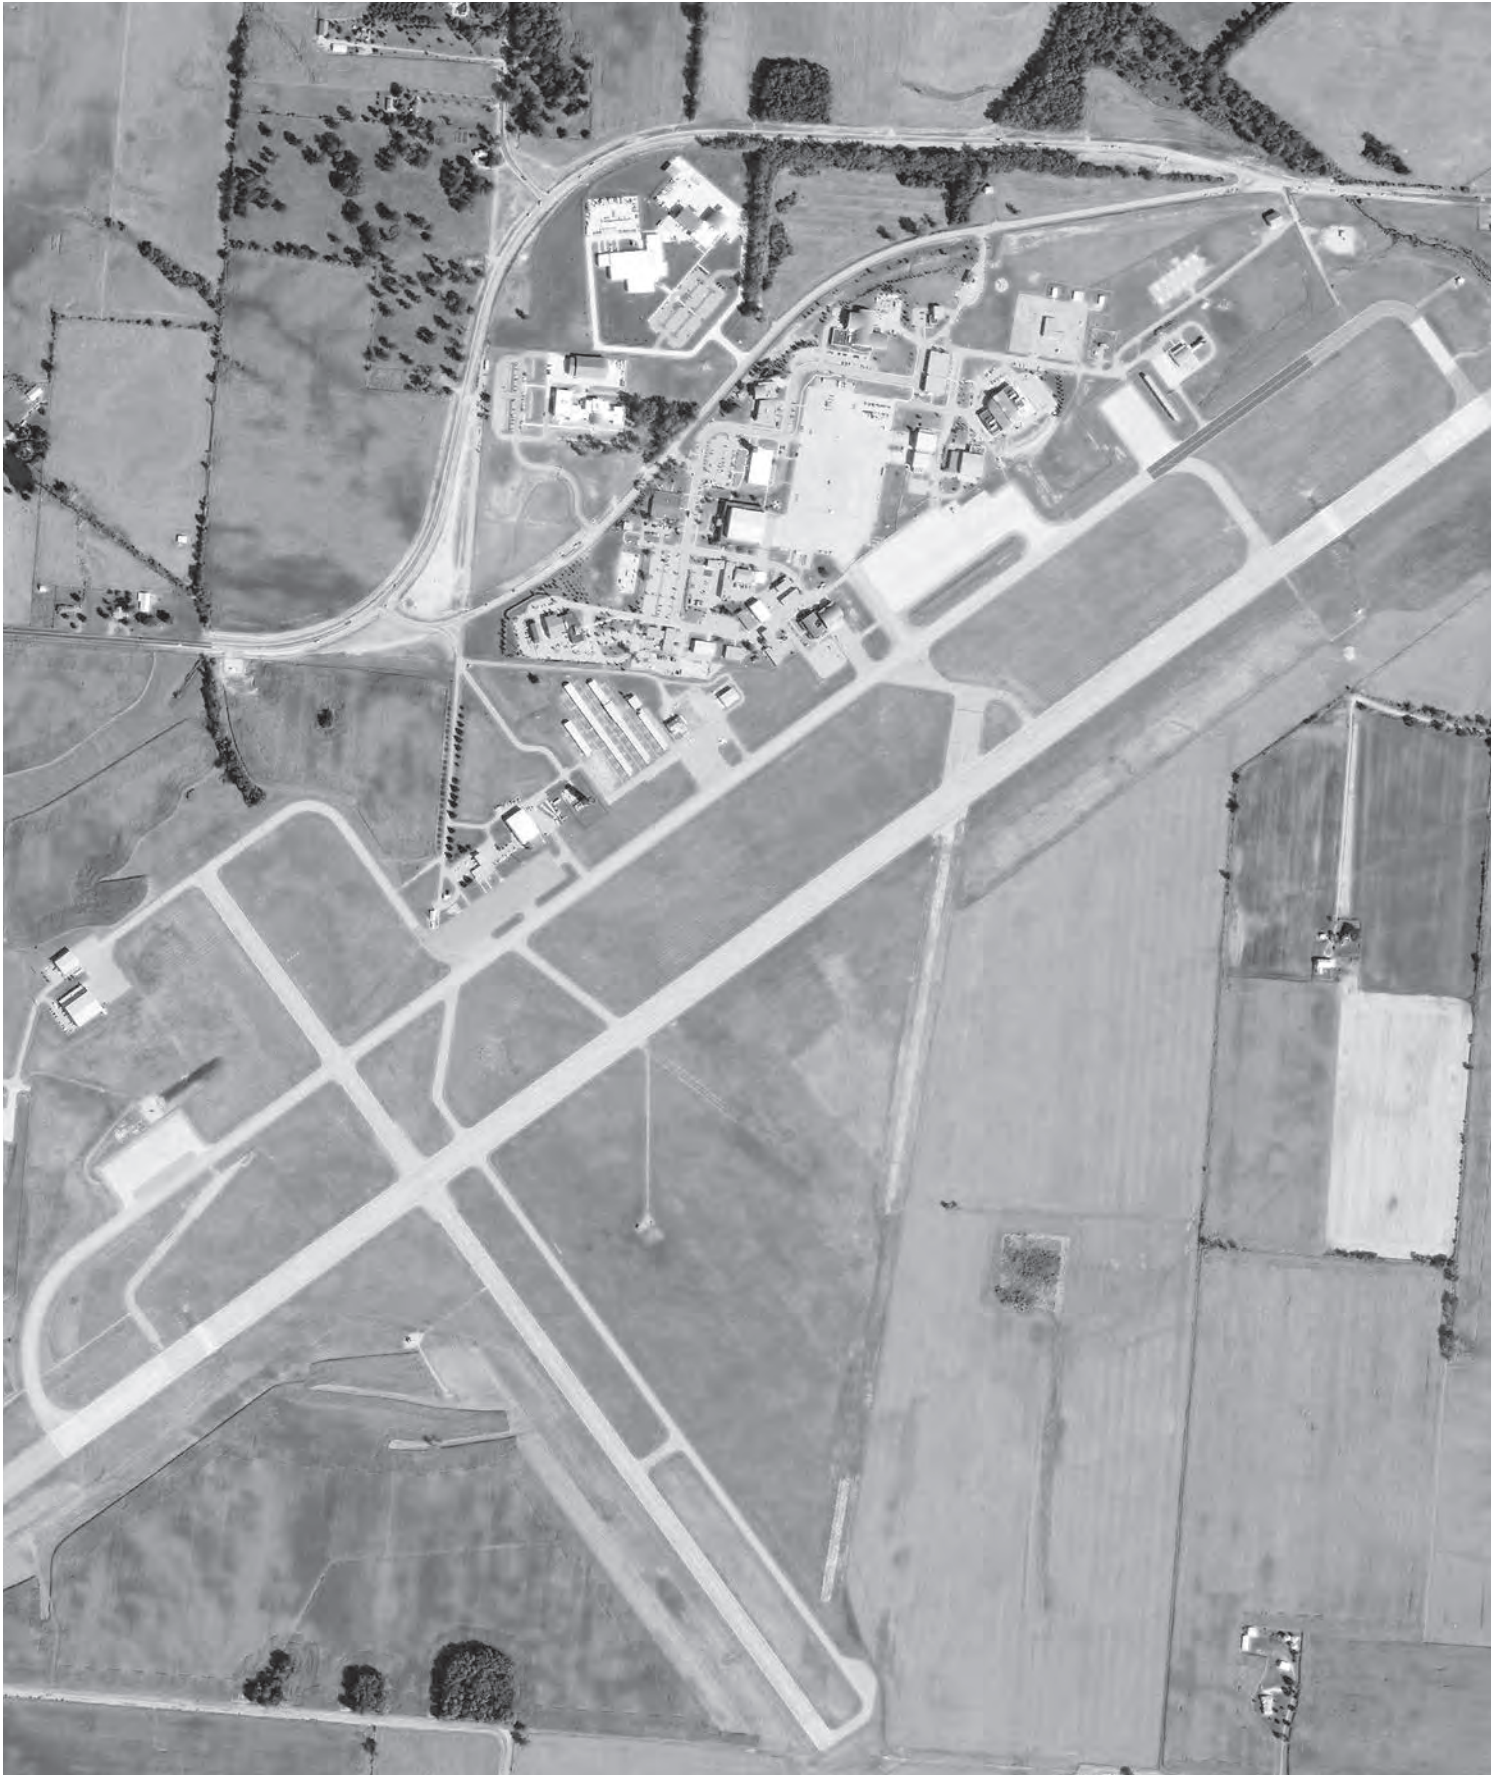
APPENDIX J: PRIOR WILDLIFE HAZARD RECOMMENDATIONS - WHA 2004
