# SPRINGFIELD GUIDELINES FOR HISTORIC PROPERTIES

JUDITH B. WILLIAMS  
HISTORIC PRESERVATION CONSULTANT  
COLUMBUS, OHIO

June, 2010

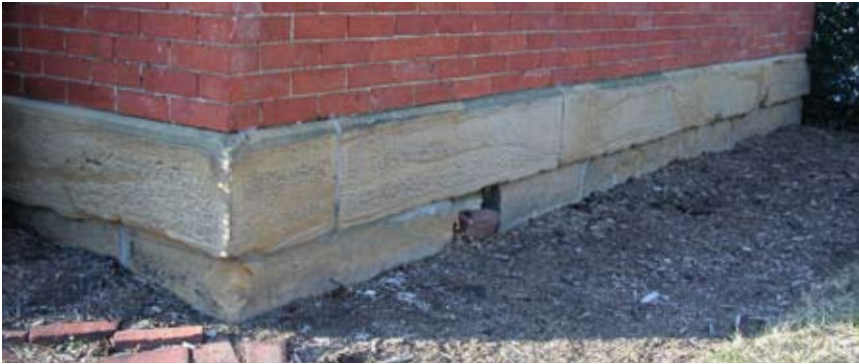
{PHOTO 1} A foundation of cut sandstone blocks that form a water table for this brick building.

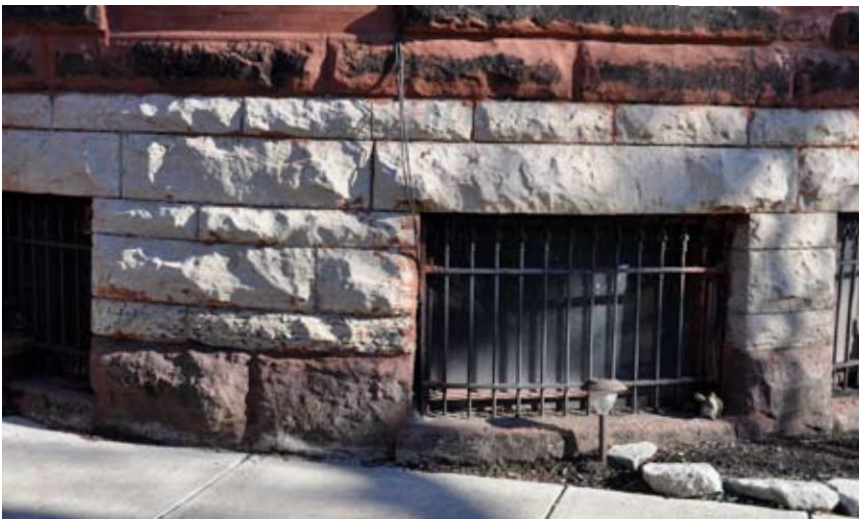
{PHOTO 2} Rock-faced sandstone blocks form a distinctive foundation on this 19th century home. Note the wrought iron security grille at the window opening.

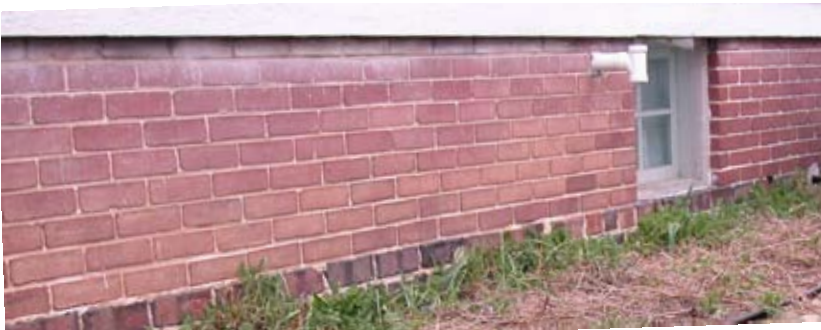
{ PHOTO 4 }

An example of a brick foundation

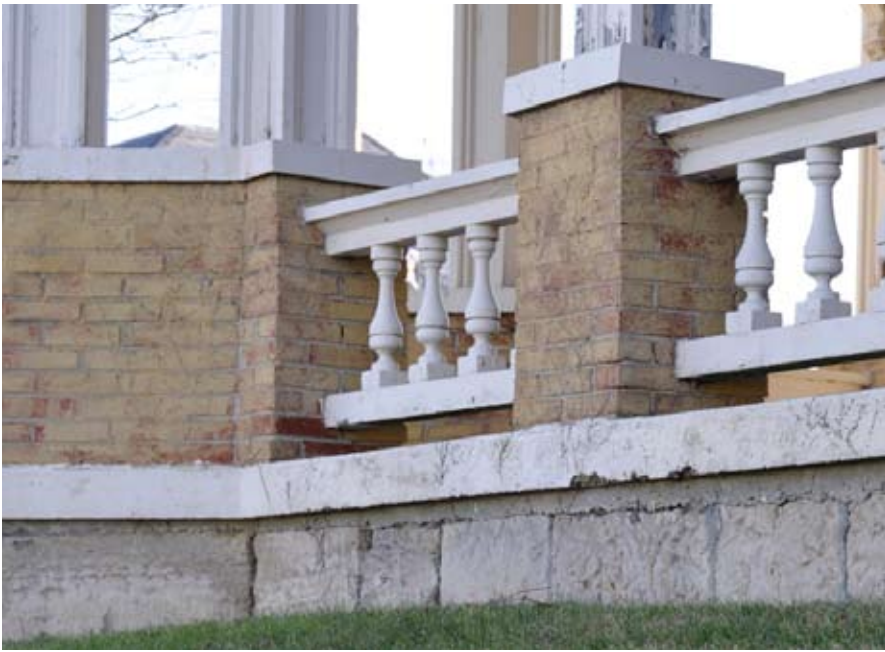
{ PHOTO 5 } — This porch foundation, with its distinctive stone water table, is an architecturally significant feature of the house and should be maintained along with the main building foundation.

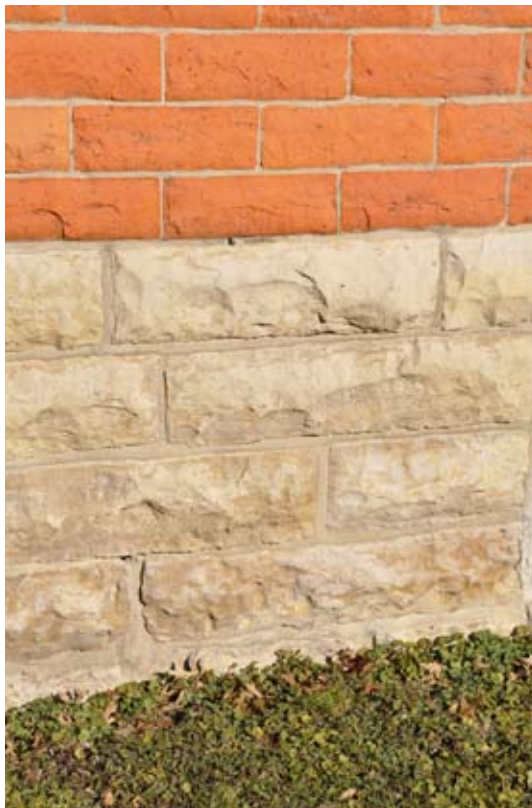
[ PHOTO 6 ] The masonry joints in this sandstone foundation have been carefully repointed to ensure the stability of the foundation wall.

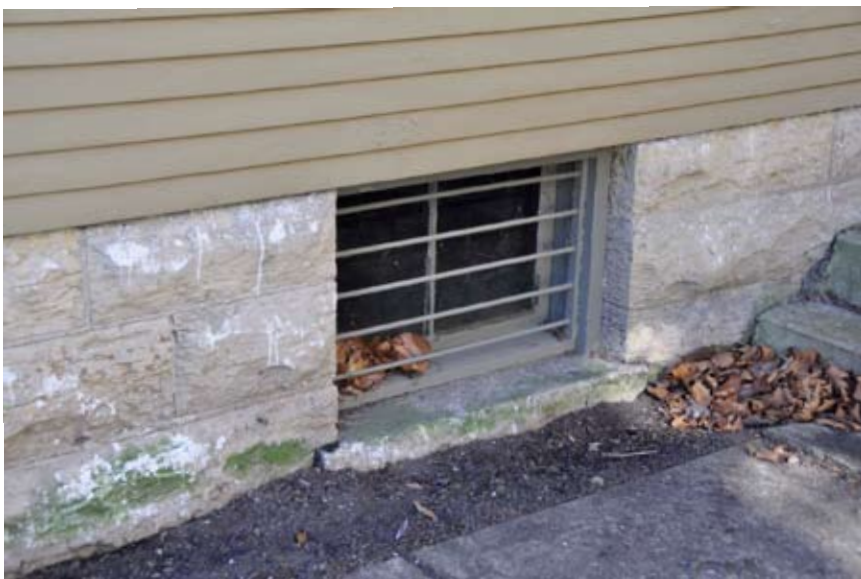
[ PHOTO 7 ] Simple horizontal or vertical metal bars would be appropriate security grilles for most foundation windows on historic buildings.

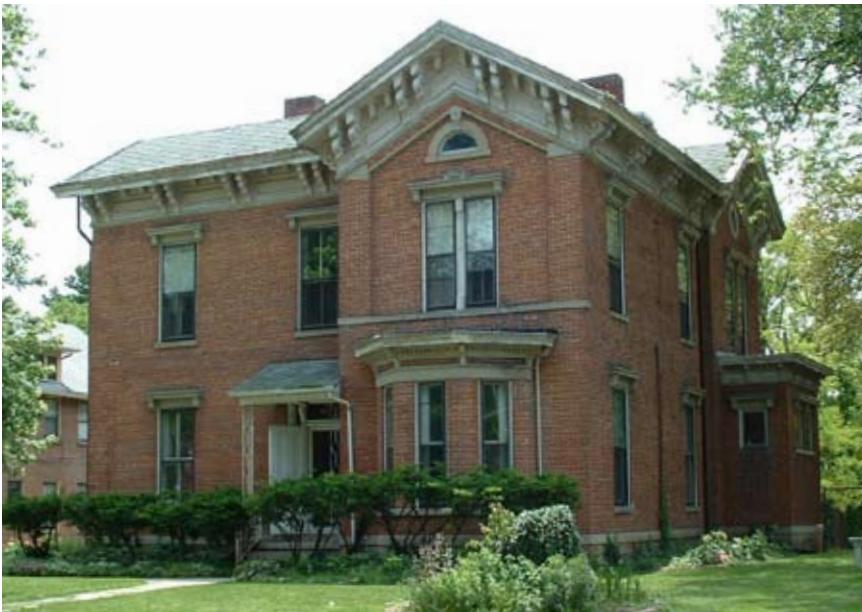
{ PHOTO 1 } A 19th century residence with brick bearing wall construction.

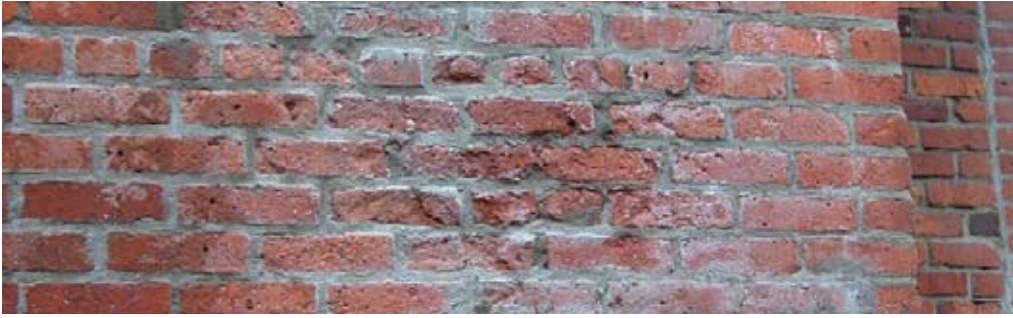
{ PHOTO 6 } *Damage to the masonry is evident on this wall, which has suffered from poor repointing techniques and moisture penetration that caused efflorescence and spalled brick.*

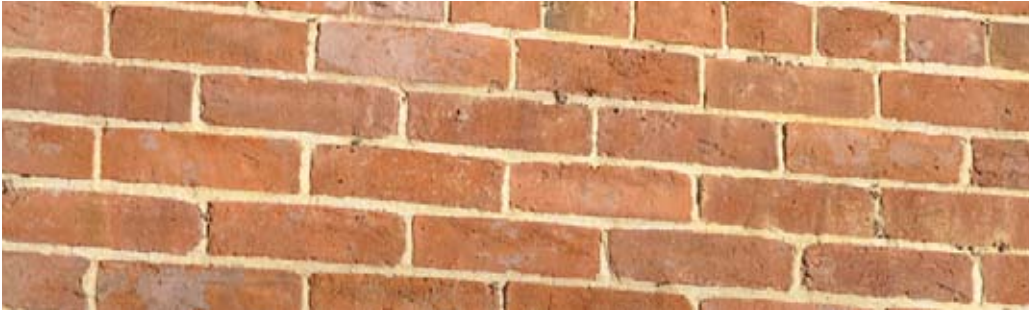
[ PHOTO 8 ] — In addition to matching the joint tooling, be sure that the mortar mix, texture and color is appropriate for the historic masonry.

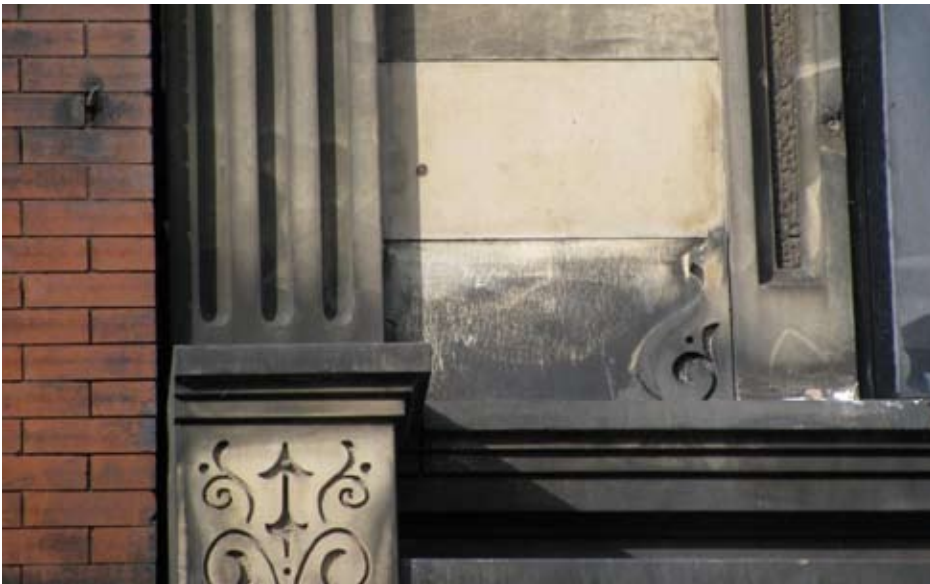
[ PHOTO 9 ] A test patch is normally required for a cleaning project that uses chemical methods to remove dirt. This example shows the results of a test cleaning, which will be examined to make sure that the stone surface was not damaged by the cleaning method.

B3. For any masonry cleaning, use the gentlest means possible in order to avoid damaging the masonry. To obtain staff approval, submit appropriate cleaning specifications and a sample cleaned area. Remember, the darkened, weathered “patina” that masonry acquires over time is part of the building’s history. The cleaning method must not damage the historic masonry.

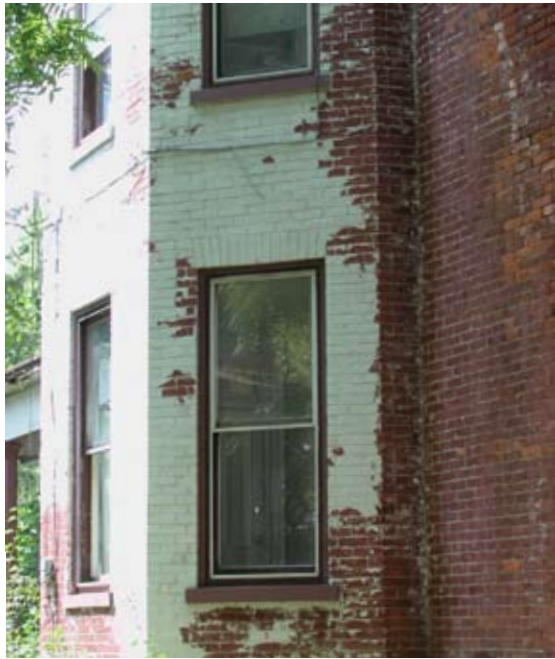
[ PHOTO 10 ] Paint removal from brick or stone can be difficult to achieve and is not always recommended. It must be carefully done to ensure that the masonry itself is not damaged.

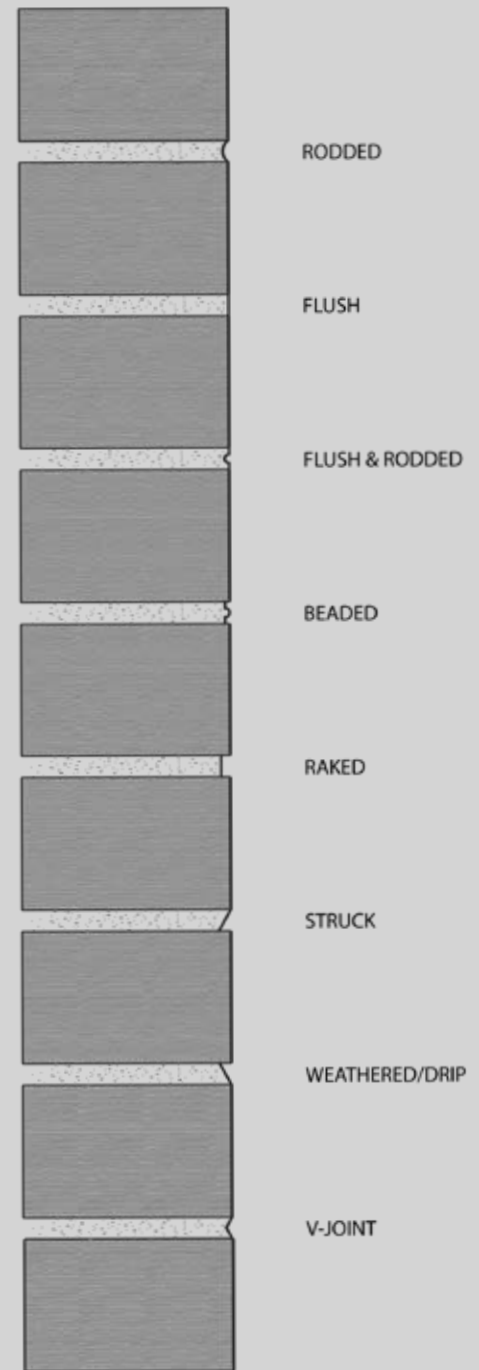
[ ILLUSTRATION 1 ]  
Various types of historic mortar joint profiles.

Extreme care must be taken when preparing joints for repointing. Old mortar should be removed to a minimum depth of 2 to 2-1/2 times the width of the joint. The best solution is to use hand tools such as chisels and mash hammers, especially in a small area. Major damage can be caused by the use of power tools, such as grinders, as the brick or stone can be chipped or damaged. Power tools are rarely recommended for historic brick masonry. However, under certain circumstances, thin diamond-bladed grinders may be used to cut out horizontal joints only on hard portland cement mortar common to most early-20th century masonry buildings. Where horizontal joints are uniform and fairly wide, it may be possible to use a power masonry saw to assist the removal of mortar, such as by cutting along the middle of the joint; final mortar removal from the sides of the joints still should be done with a hand chisel and hammer. Power tools should never be used on vertical joints because of the damage that can be caused to the masonry above and below the joint.

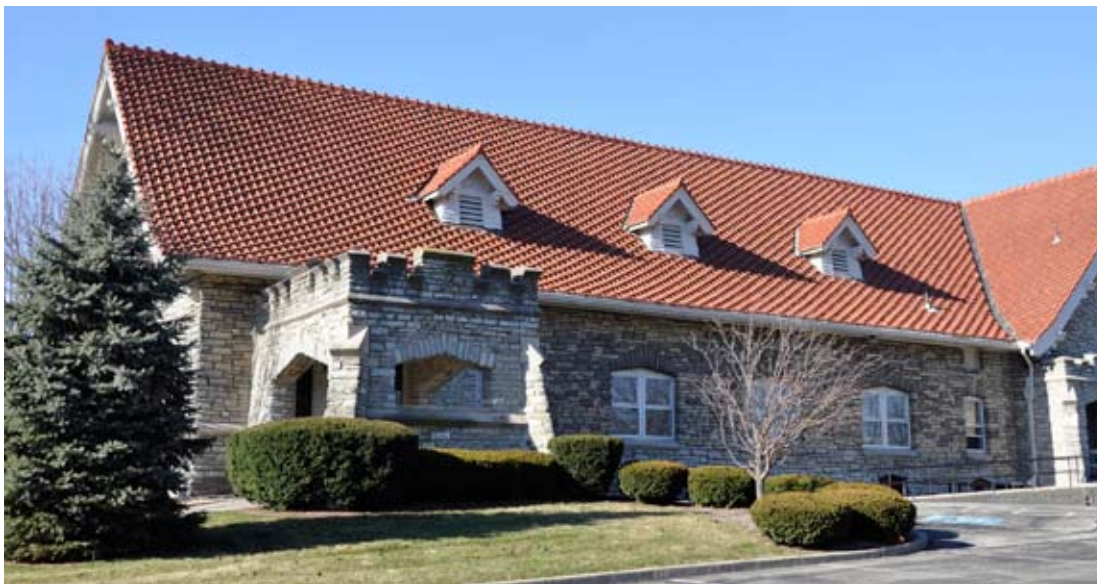
[ PHOTO 3 ] *A distinctive example of a clay tile roof in Springfield*

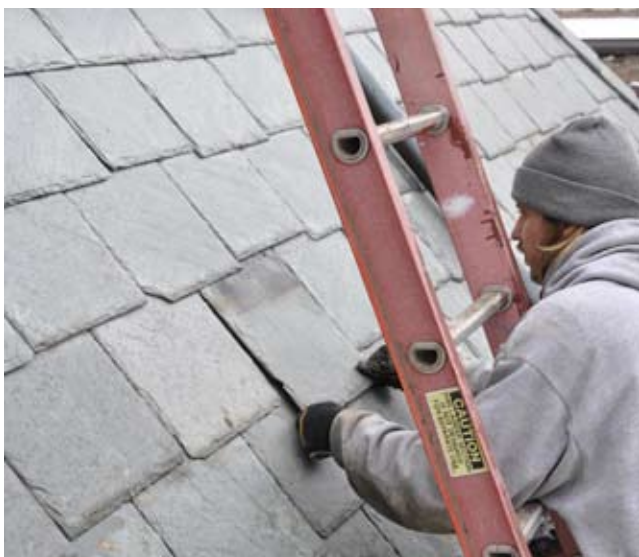
[ PHOTO 4 ]  
*A workman replaces an individual damaged slate with a new slate that has been carefully selected to match the size, color and qualities of the original.*

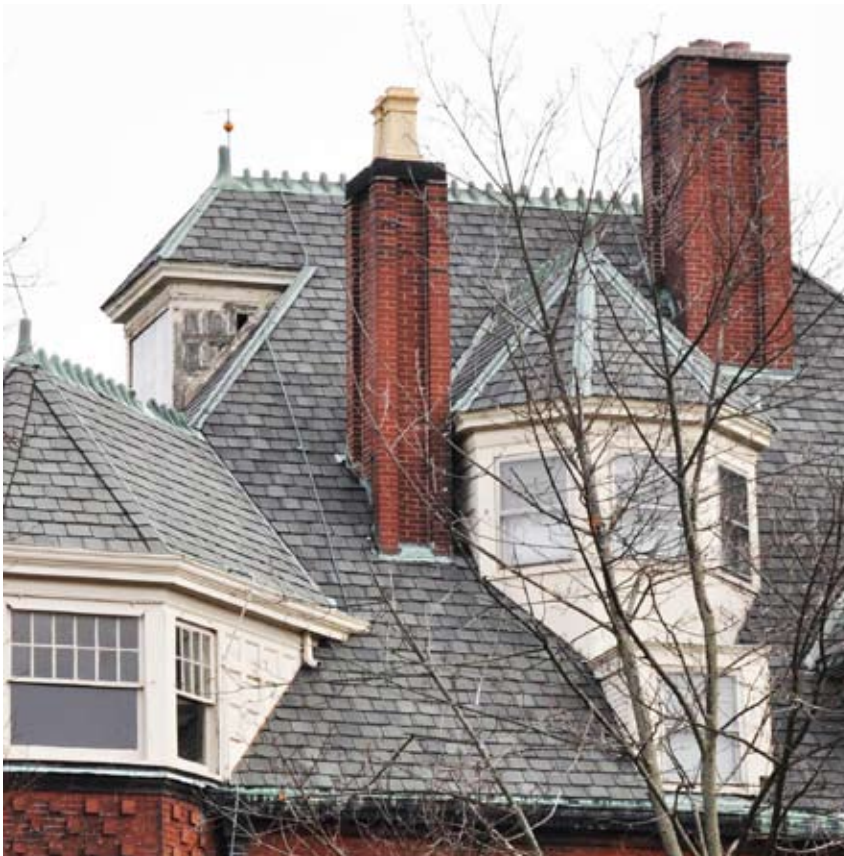
[ PHOTO 5 ] This roof replacement used a dimensional shingle that recalls the appearance of historic slate. Note how the original copper ridge caps were retained.

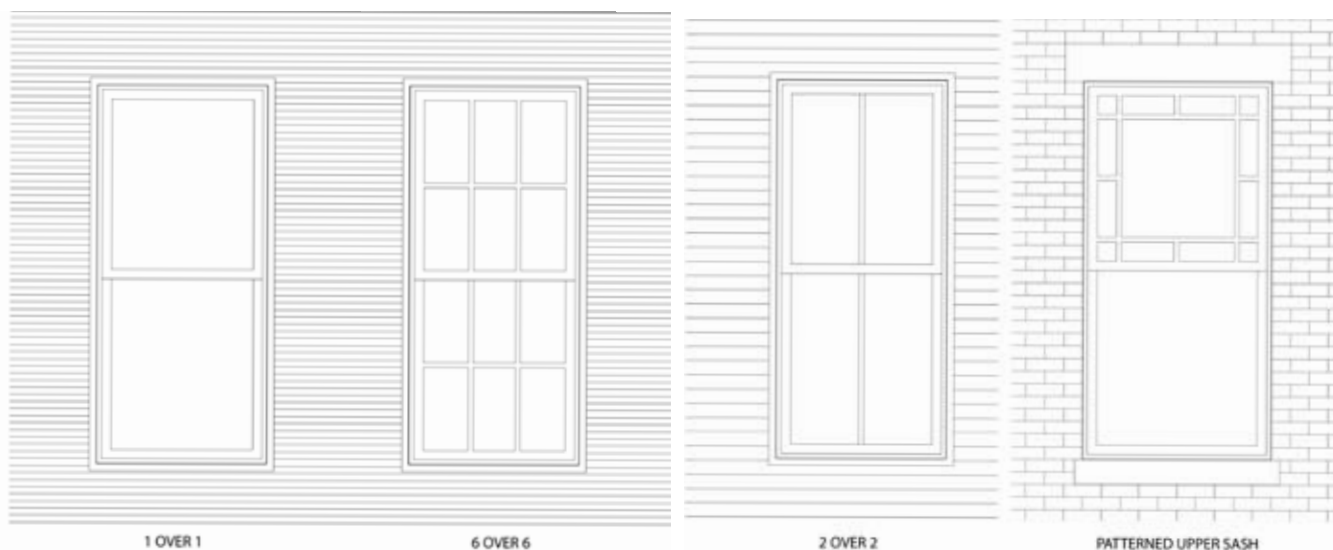
[ ILLUSTRATION 1 ] Examples of double-hung window configurations

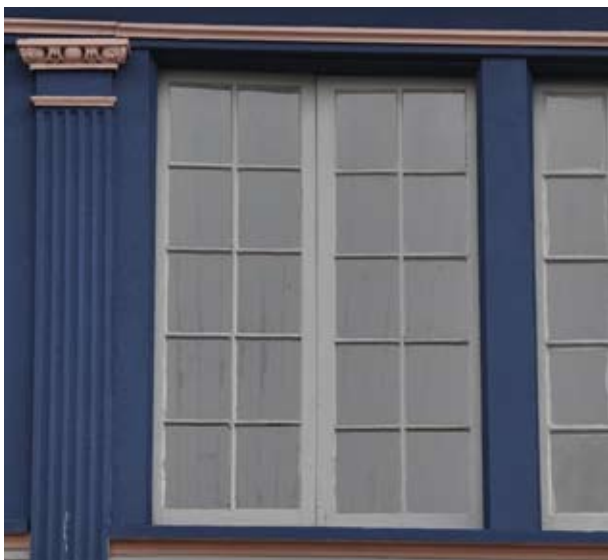
[ PHOTO 4 ] A casement window, where the window opens to the side on a hinge.

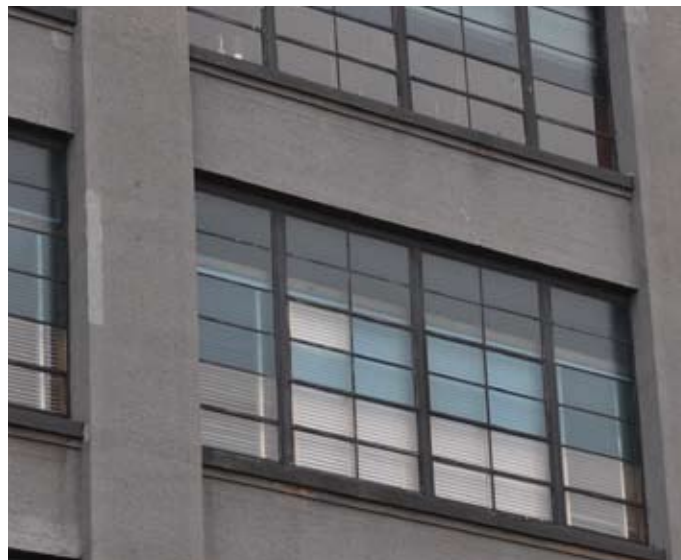
[ PHOTO 5 ] An example of an industrial style hopper window, where one section opens horizontally on a hinge for ventilation purposes.

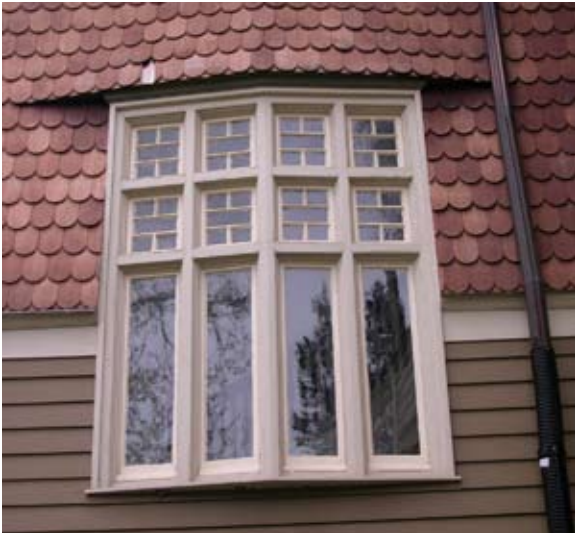
[ PHOTO 6 ] *The transom (multi-pane) in this window is an example of a fixed window.*

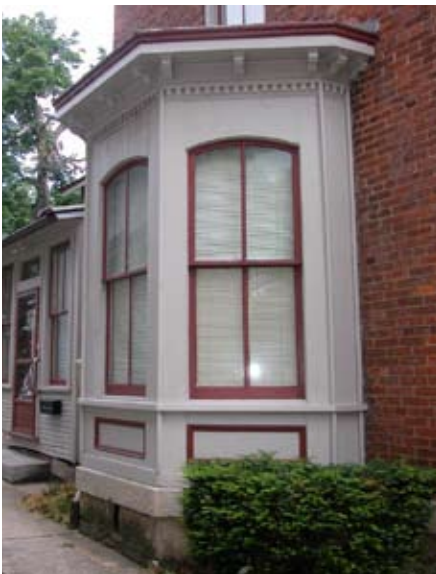
[ PHOTO 8 ] *This bay window on a 19th century Italianate style house in Springfield rests on its own foundation.*

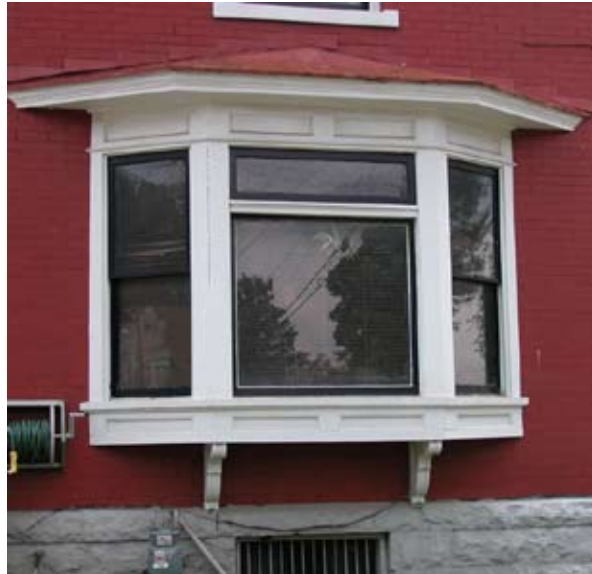
[ PHOTO 9 ] *A bay window with the projection supported by brackets above the ground.*

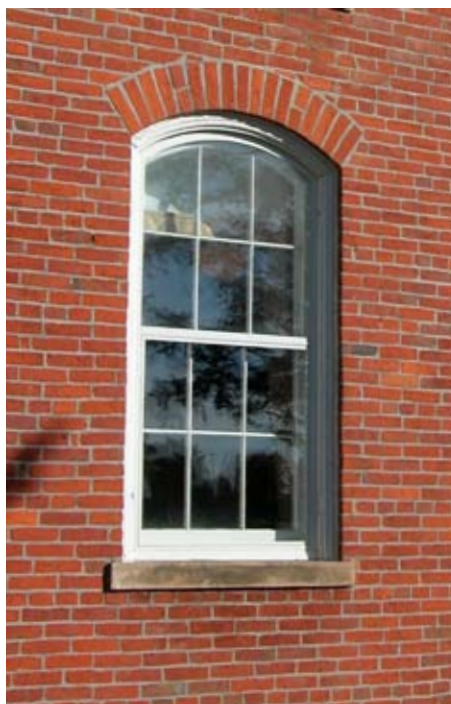
[ PHOTO 10 ] An example of a wood window replacement that matches the historic window exactly, including material.

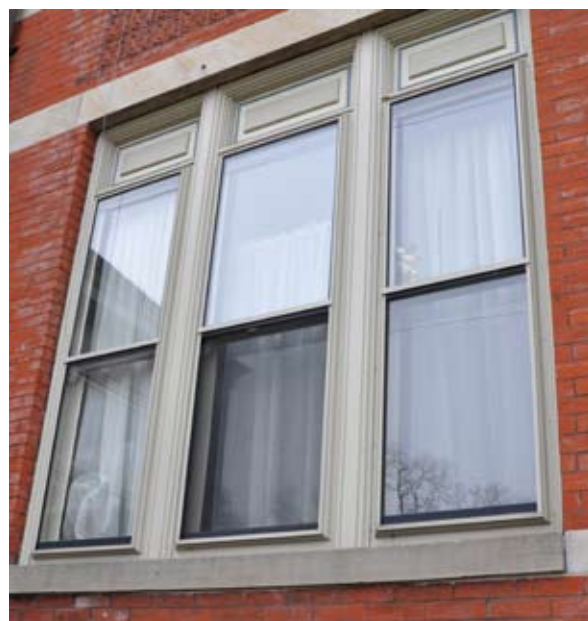
[ PHOTO 12 ] *These storm windows fit the openings exactly, match the trim color, and provide insulating protection for the historic wood windows.*

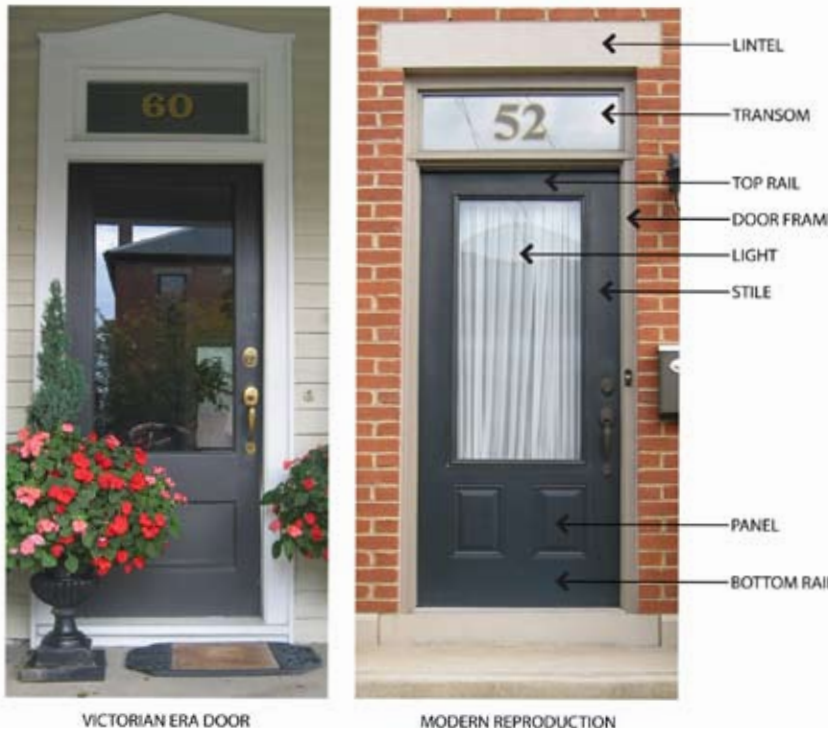
[ ILLUSTRATION 1 ]  
The photo on the right is an example of an appropriate replacement when a historic door is missing. The characteristics of the new door are based upon typical features of a historic door, but are executed with new materials.

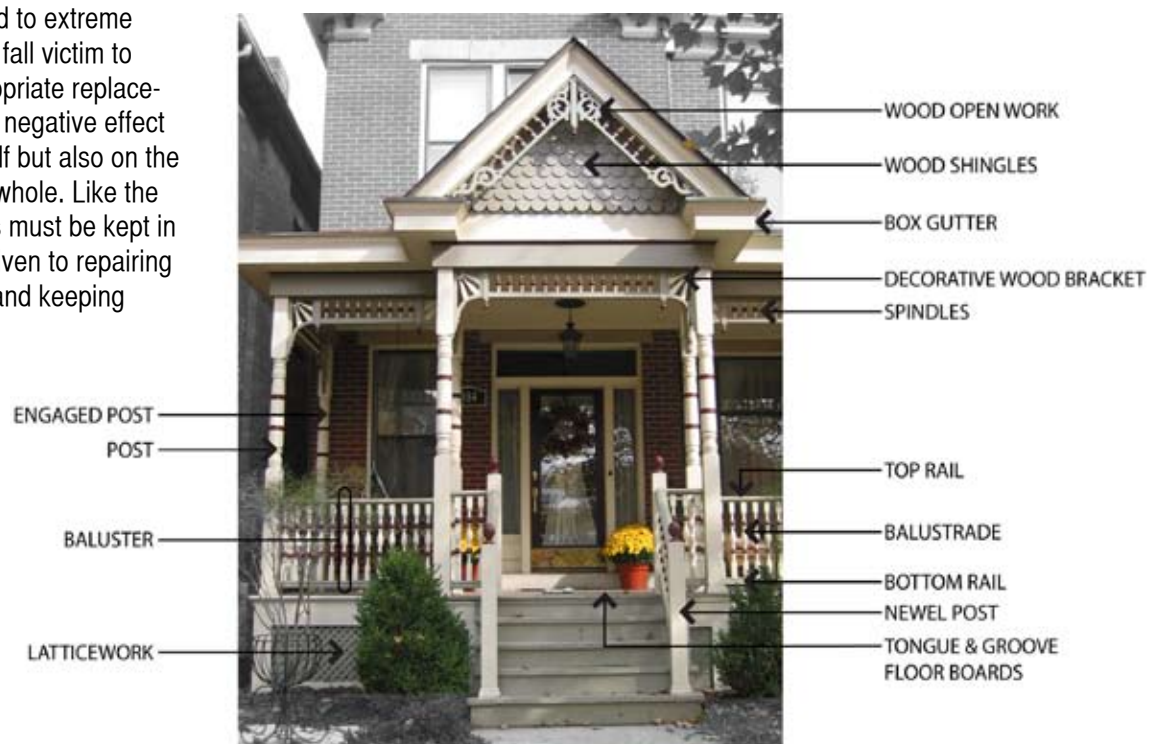
[ ILLUSTRATION 1 ] Parts of a Typical Porch

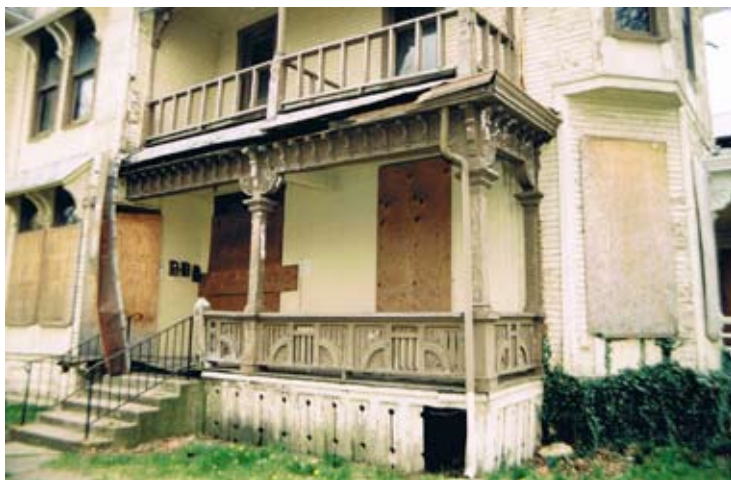
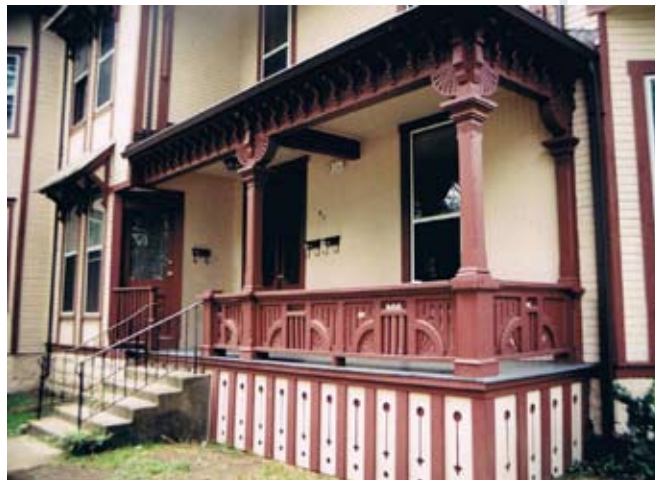
[ PHOTOS 6 AND 7 ] A porch on South Fountain Avenue before and after repair. The porch remains unchanged, with repair of damaged features and replacement of missing pieces to match the originals.

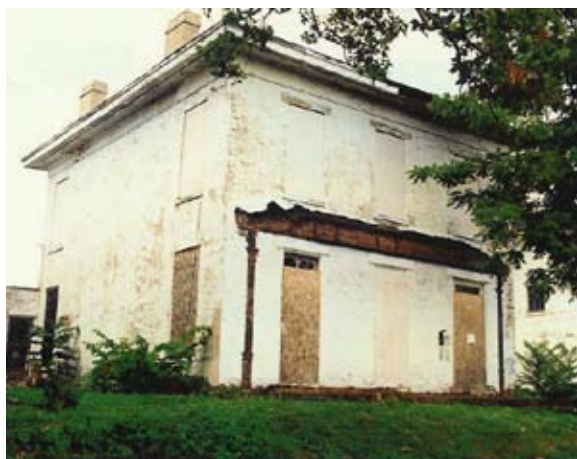
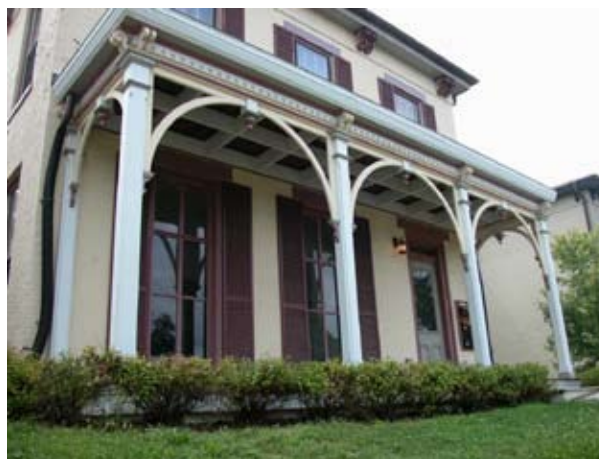
[ PHOTOS 8 AND 9 ] Before and after views show this S. Fountain Avenue house in 1995 and today. Paint shadows illustrate the profile of the original porch in the earlier photo. The new porch design makes use of typical porch characteristics for the period, including the chamfered posts and brackets, but keeps the elements simple.

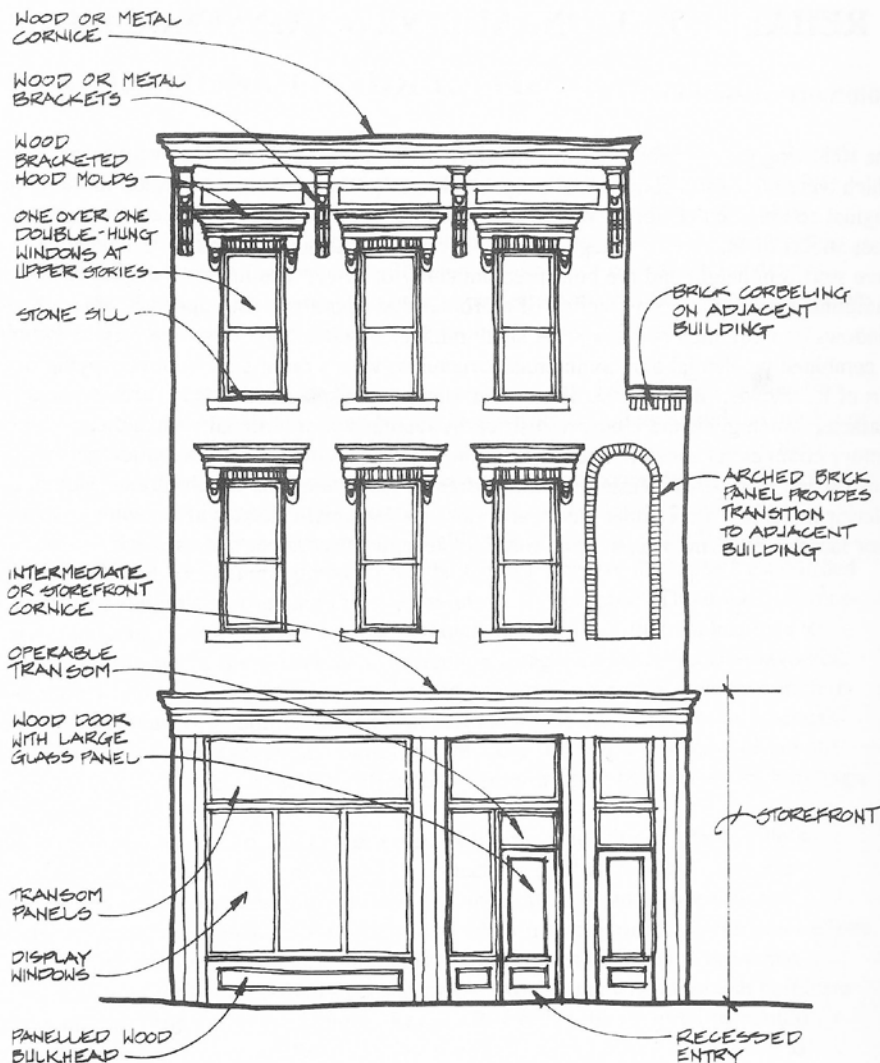
[ ILLUSTRATION 1 ] *Parts of a Typical Commercial Building.*

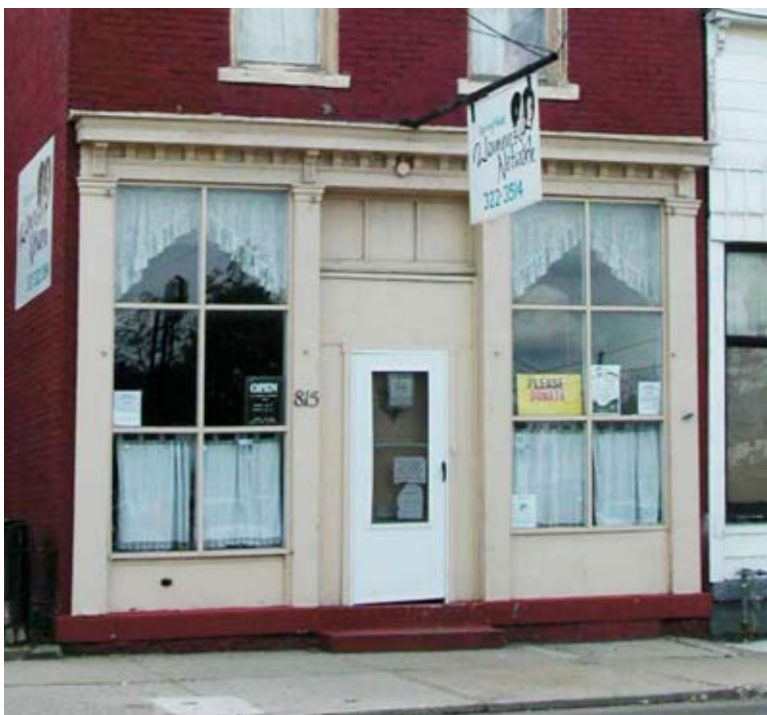
[ PHOTO 1 ] Although the entrance has been filled in with a smaller door, this is a good example of a 19th century storefront in Springfield. Instead of a transom, the display windows to either side of the door are tall.

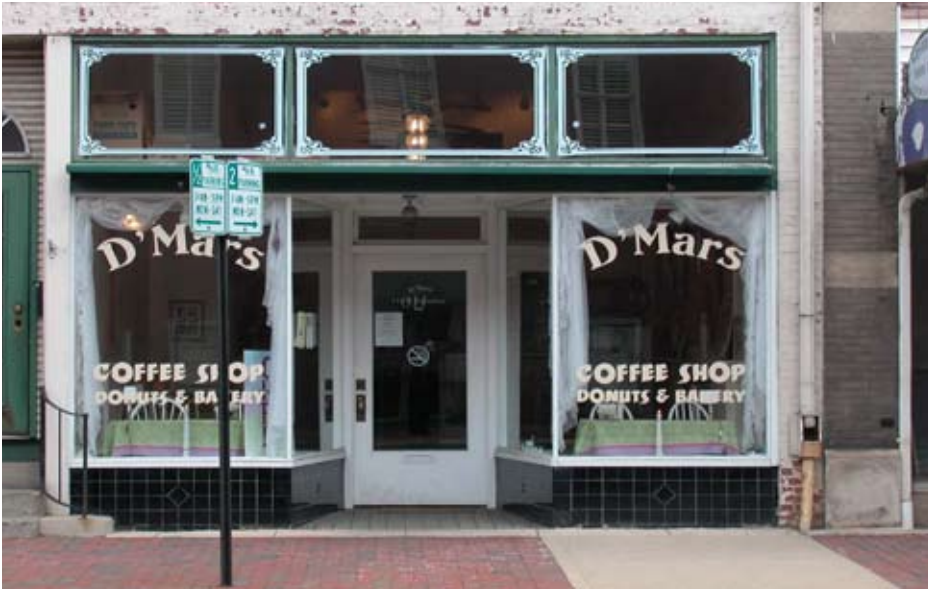
[ PHOTO 3 ] An example of a traditional storefront with recessed entry. Transparency & use of original materials is key.

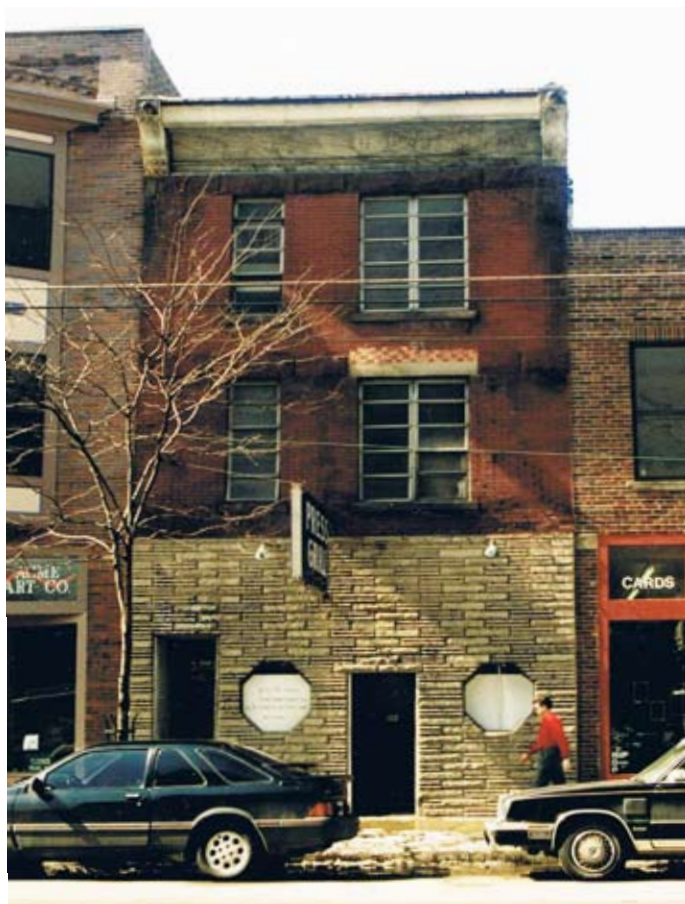
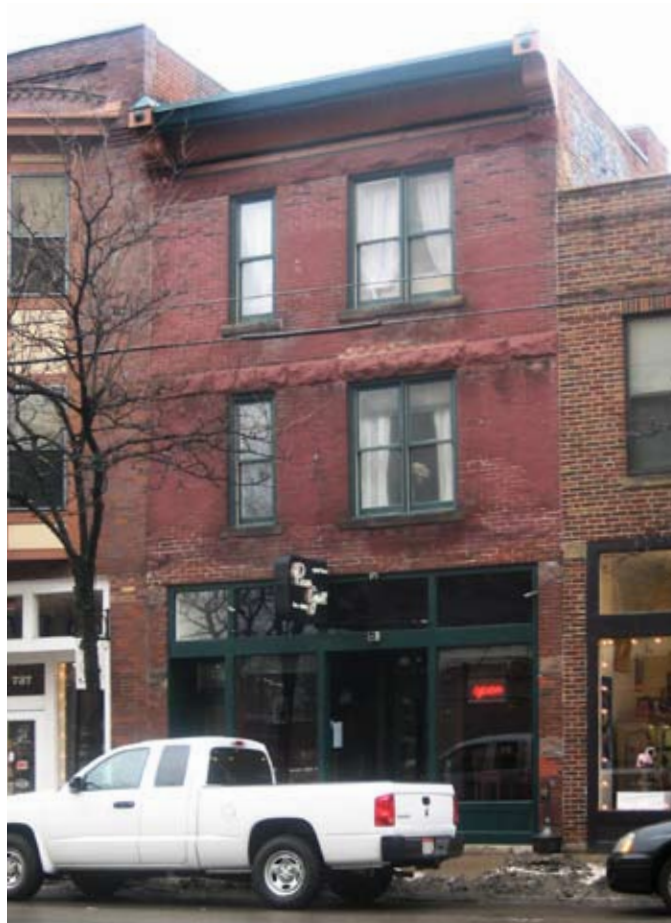
[ PHOTOS 4, 5 ] These photos show before and after views of a commercial building where the original storefront was completely missing. The new storefront was designed to be simple and compatible with the historic building, an example of choice #2 above.

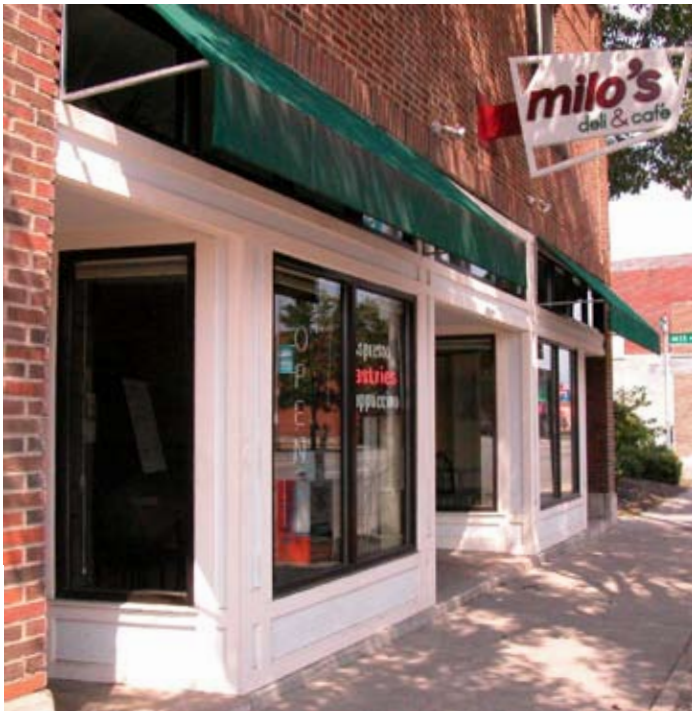
[ PHOTO 5 ] An example of a fabric awning mounted on an aluminum frame with open ends. This type of awning is a contemporary and compatible treatment for most historic commercial buildings.

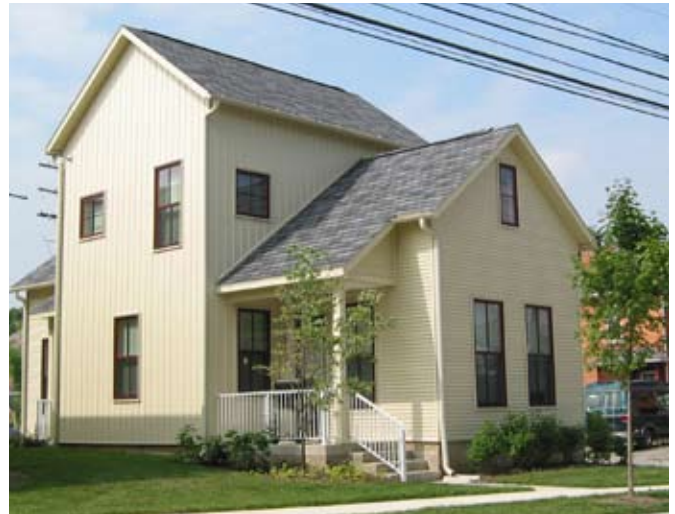
[ PHOTO 4 ] This example of new infill construction uses common proportions and roof forms in its historic area, but is clad in newer materials that recall historic materials. These include aluminum siding in two profiles (horizontal lap siding and vertical board & batten), aluminum-clad double hung windows, asphalt shingle roof, and split-face concrete block foundation.

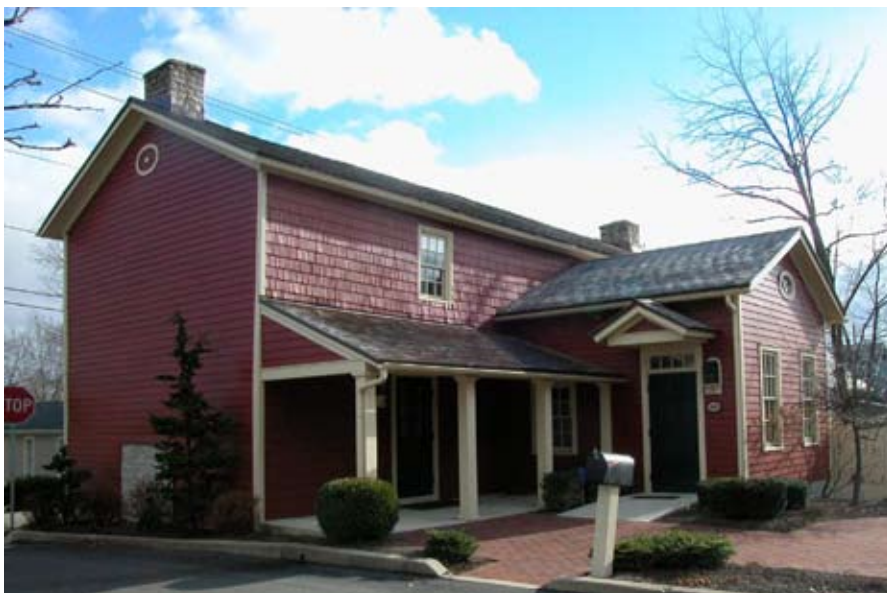
[ PHOTO 5 ] An example of an addition to the back of a property in a historic area. It is subsidiary to the original building, including its lower roofline, and is designed to be compatible with the simple style and materials of the original. The historic character and features of the original building remain intact with this addition.
